## **HERITAGE HALTON HILLS COMMITTEE AGENDA**

## **BUILDING CONDITION ASSESSMENT**

9608 Eighth Line  
Halton Hills, Ontario

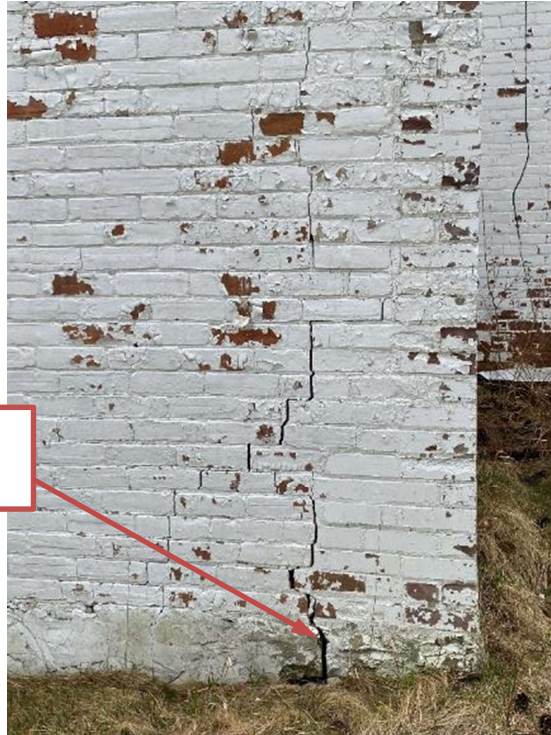
Figure 11.0

movement is concerning and the cracks in the wall will continue to grow as moisture penetrates the wall, and the effects of freeze-thaw continue to expand the gap in the walls.

Original Farmhouse  
– Cracked Wall
