HERITAGE HALTON HILLS COMMITTEE AGENDA

Research and Evaluation Report

The Ford House and Kirkpatrick Blacksmith Shop
12438 Kirkpatrick Lane, Limehouse, Town of Halton Hills

May 2021

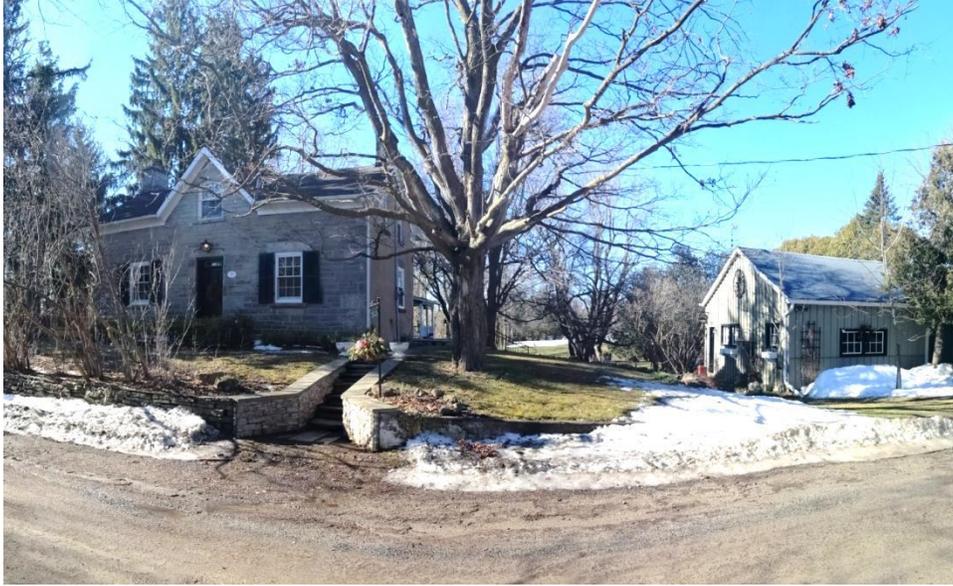
The existing 1862 residential structure on the property, known as the Ford House, is a one-and-a-half storey structure constructed of Credit Valley Stone in a Regency vernacular style (**Error! Reference source not found.**). The house is constructed on a rise above street level behind a stone retaining wall with soft landscaping between the retaining wall and the front elevation, with access from the street provided by a flight of shallow stone stairs. The gable roof of the original building features symmetrical chimneys on the east and west ends of the roof and a central gable on the front (north) elevation.

Figure 21: 12438 Kirkpatrick Lane (Town of Halton Hills 2021)

The Ford House is a representative example of a mid-nineteenth century Regency residential building. The one-and-a-half storey Regency residential building is constructed of limestone with a stone foundation. The building features a gable roof with symmetrically placed chimneys and returning eaves on the east and west elevations. The front elevation includes a central entrance with a flat-headed door opening and stone lintel, symmetrically placed flat-headed window openings on either side of the central entrance with stone sills and lintels with wooden shutters, and segmentally arched window openings above the central entrance beneath the central gable. While the east and west elevations are clad with stucco, the front elevation features cut limestone blocks. The east and west elevations also feature symmetrically placed window openings at the first and second storeys with stone sills.

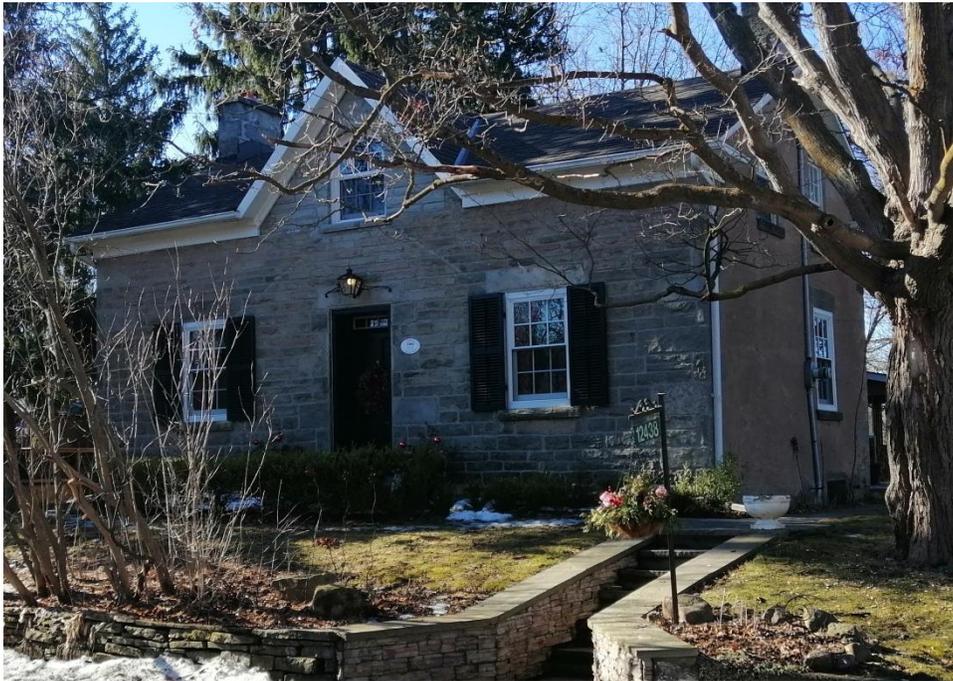
The limestone front elevation (Figure 22) contains a central-entrance with flat-headed door opening with a stone lintel, and two symmetrically placed flat headed window openings with wooden shutters on either side of the entrance, also with stone lintels and sills. Centered beneath the gable is a segmentally arched window opening with stone sill.

Figure 22: 12438 Kirkpatrick Lane, Front Elevation (Town of Halton Hills 2021)

- The scale, form, and massing of the 1862, one-and-a-half storey Regency limestone residential building with stone foundation;
- The gable roof with symmetrically placed chimneys and returning eaves on the east and west elevations;
- On the front (north) elevation:
 - Central entrance with flat-headed door opening and stone lintel
 - Symmetrically placed flat-headed window openings on either side of the central entrance with stone sills and lintels
 - Segmentally arched window openings above the central entrance beneath the central gable
 - Limestone block construction with stone quoining at each corner
- On the east and west elevations, the symmetrically placed window openings at the first and second storeys with stone sills

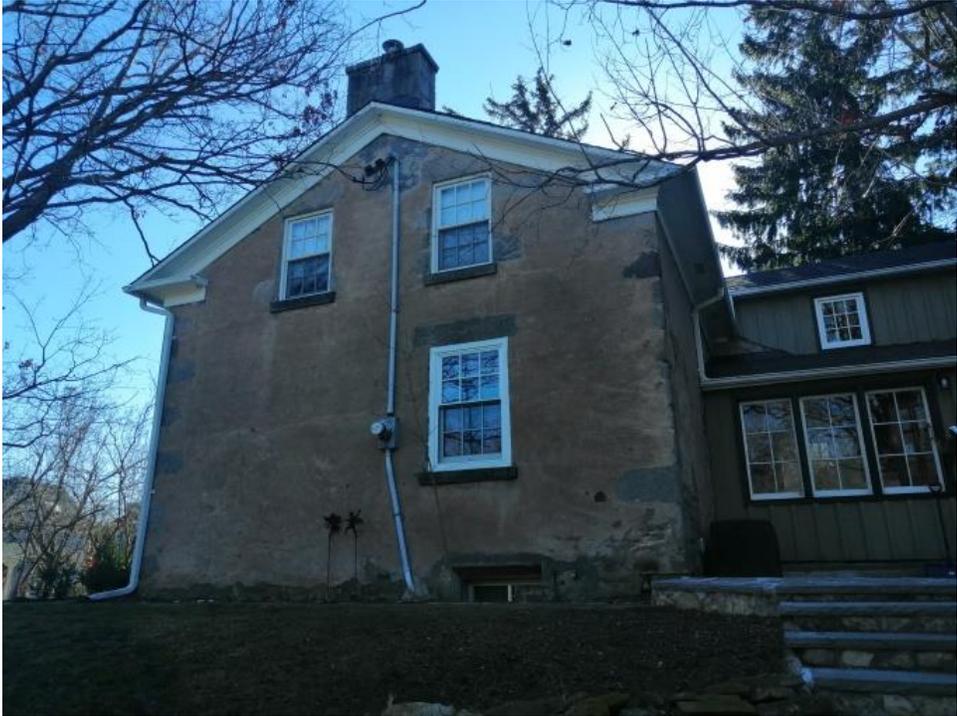
The side (west) elevation (Figure 23) is covered with stucco and features returning eaves and three flat-headed window openings: one on the first storey with stone sill, and two symmetrically placed windows at the second storey. A flat-headed window opening is also located at the basement level.

Figure 23: Ford House, Partial Side (West) Elevation (Town of Halton Hills 2021)

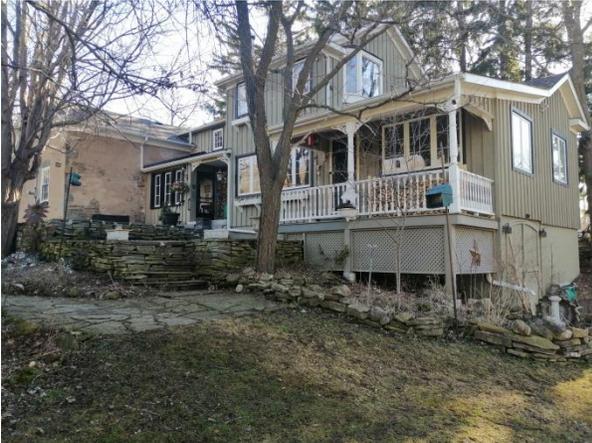
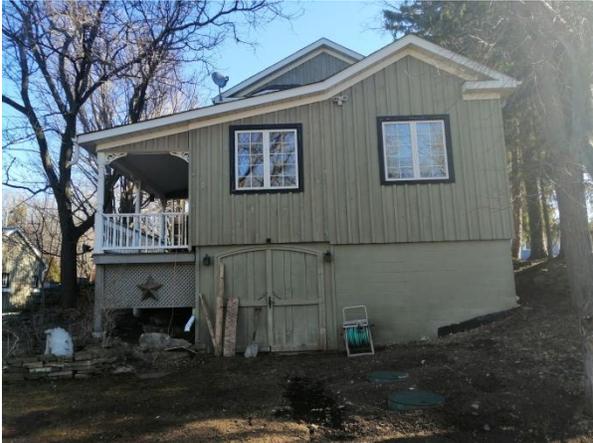
At the rear of the original structure is a gable-roofed addition that extends from one-and-a-half storeys to two-storeys and then to one storey at the rear (Figure 24 and Figure 25). The stuccoed rear elevation of the original building is mostly obscured by the rear addition. The addition, accessed by a flight of stone steps extending to a stone patio, is clad with board-and-batten siding and includes a covered porch on the west elevation. It is understood by the current owner that the first floor of the one-and-a-half storeys addition is the original kitchen wing, modified with the later addition of a second storey.

Figure 24: Ford House, Partial Side (West) Elevation (Town of Halton Hills 2021)

Figure 25: Ford House, Rear (South) Elevation (Town of Halton Hills 2021)

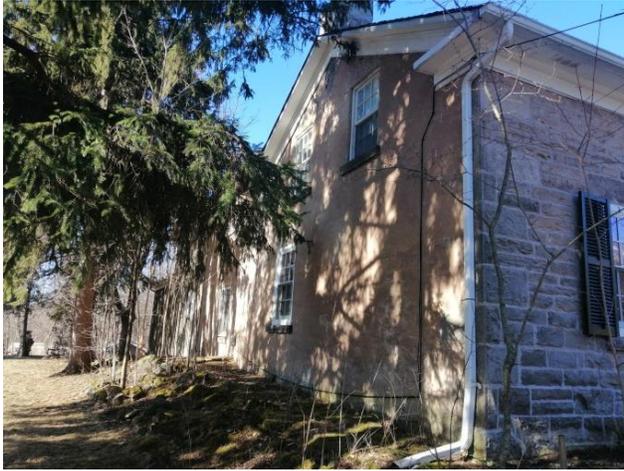
The east elevation of the 1862 structure is also stuccoed with returning eaves, and like the west elevation, features a window at the basement level, one flat-headed window at the first storey and two symmetrically placed, flat-headed window openings at the second storey beneath the gable (Figure 26).

Figure 26: Ford House, Northeast Corner looking west (Town of Halton Hills 2021)

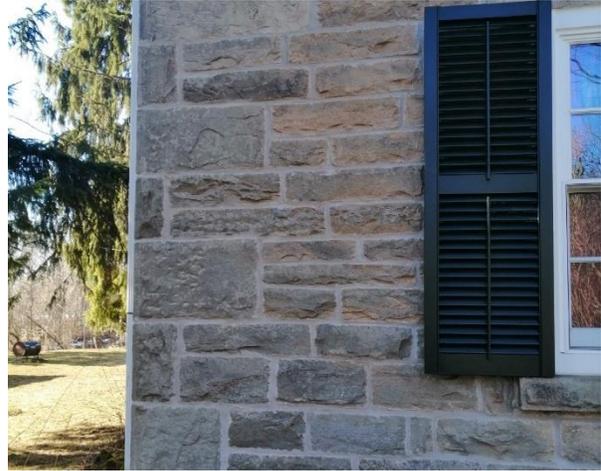
Figure 27: Ford House, detail of quoining at front elevation (Town of Halton Hills 2021)

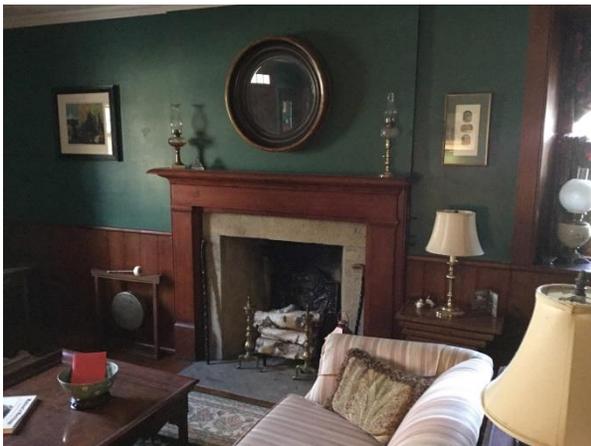
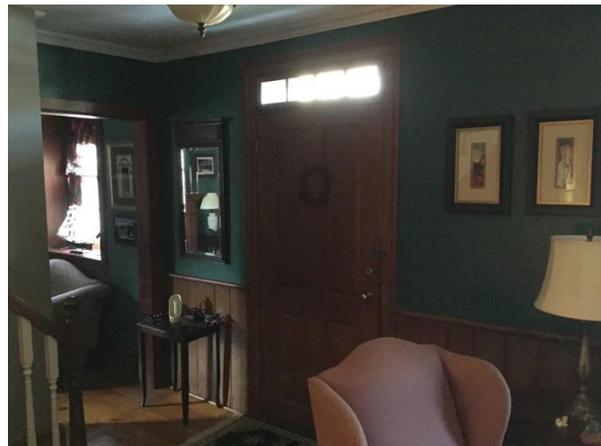
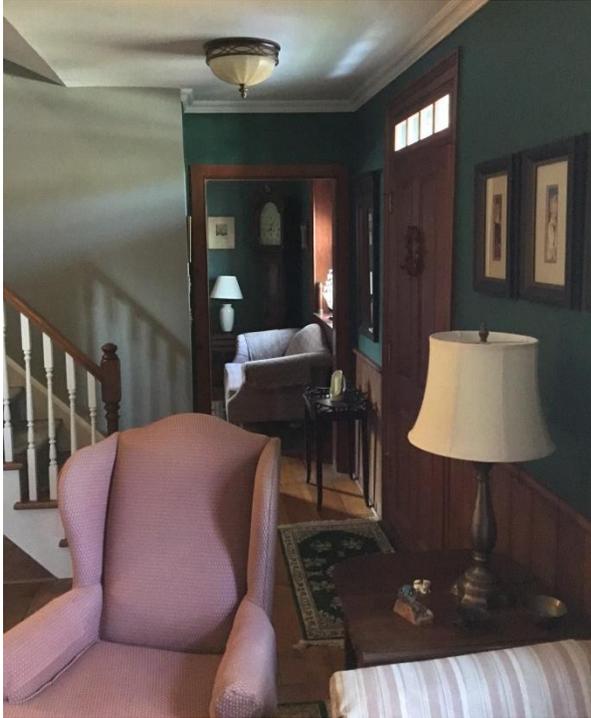
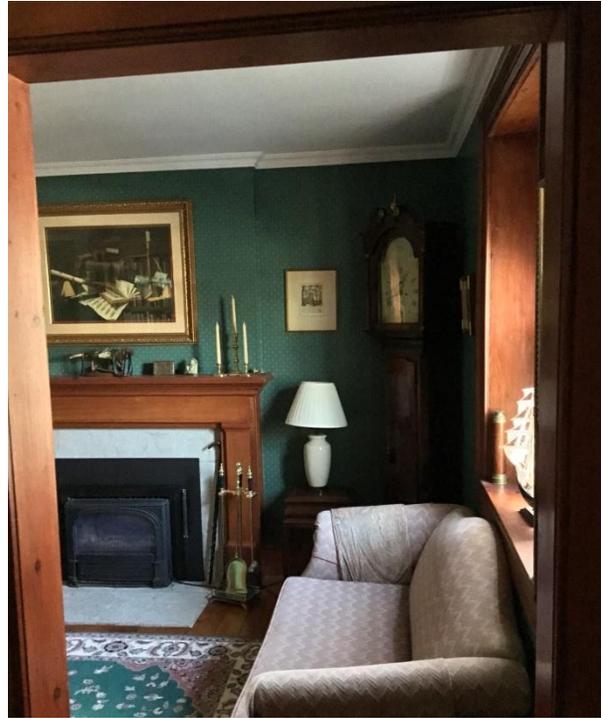
The interior of the original two-storey building has been modified, including the replacement of the original floors, replacement of walls and ceilings with drywall, and removal of a wall in the main room (Figure 28 through Figure 31). Additionally, the original staircase has been replaced. The original mouldings, trim, baseboard, fireplace woodwork and wainscoting within the main floor are still extant within the first-floor rooms, and on the second floor, despite new wiring, insulation and drywall, the current owners indicate that there are many original features remaining.

Figure 28: Ford House, looking at the east interior wall and showing restored fireplace (Town of Halton Hills 2021)

Figure 29: Ford House, looking north towards the main entrance (Town of Halton Hills 2021)

Figure 30: Ford House, looking west within the first floor showing restored original trim (Town of Halton Hills 2021)

Figure 31: Ford House, looking west within the first floor showing restored original trim and modified fireplace (Town of Halton Hills 2021)

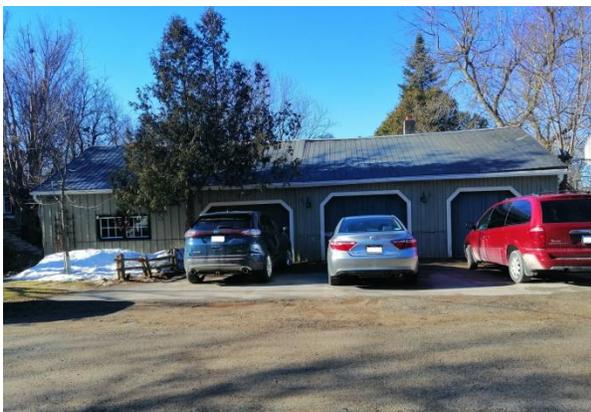
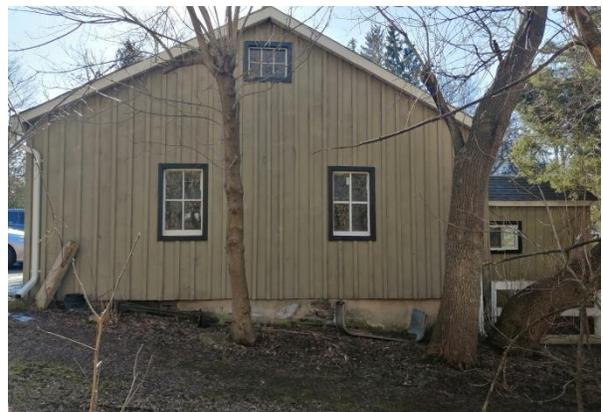
The Kirkpatrick Blacksmith Shop is located to the west of the Ford House and is also oriented towards Kirkpatrick Lane (north) (Figure 32). The mid-nineteenth-century, one-storey structure with gable roof has been overclad with board-and-batten siding that extends over the original blacksmith shop (east end) and later addition (west end). The front elevation contains a horizontal window opening with centre mullion and three garage door openings. The easternmost opening, which has been modified, is the original opening for the blacksmith shop. The side (west) elevation is also clad in board-and-batten siding (Figure 33 and Figure 34). The concrete foundation is visible beneath the cladding. The elevation features two symmetrically placed flat-headed window openings at ground level and a small horizontal window opening centered beneath the gable roof.

Figure 32: Kirkpatrick Blacksmith Shop, Front (North) Elevation (Town of Halton Hills 2021)

Figure 33: Kirkpatrick Blacksmith Shop, Side (West) Elevation (Town of Halton Hills 2021)

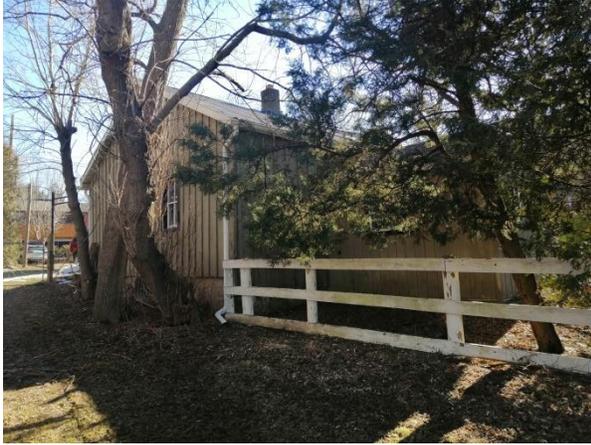
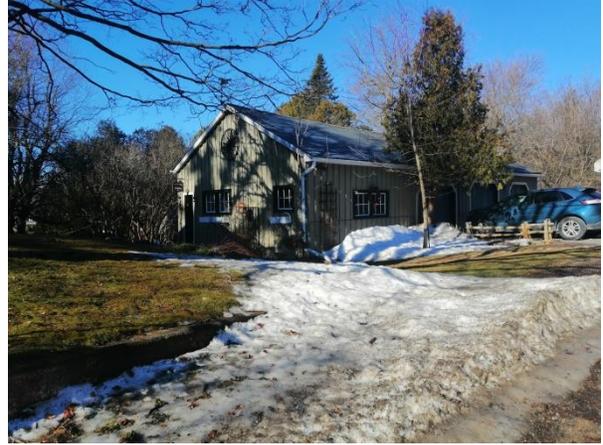
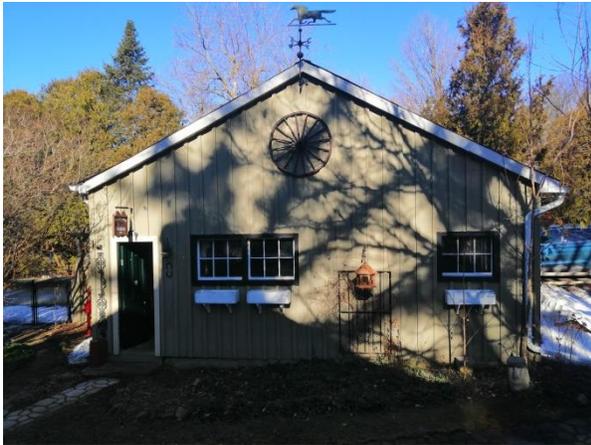
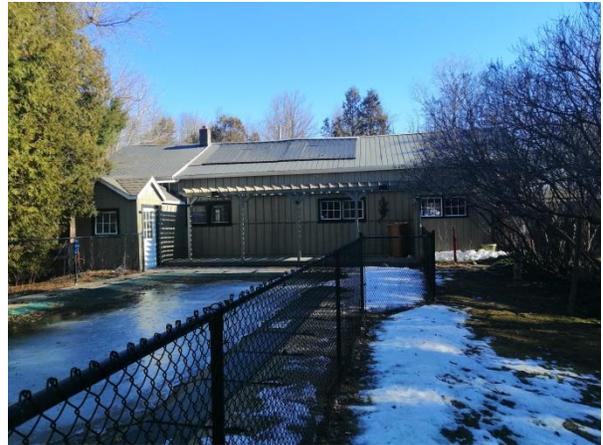
The east elevation of the blacksmith shop features a horizontal window opening with centre mullion and a smaller window opening on the north side of the elevation. The entrance is located on the south end of the east elevation (Figure 35 and Figure 36). The rear (south) elevation features three paired flat-headed window openings with a small shed addition within the pool area to the south (Figure 37).

Figure 34: Kirkpatrick Blacksmith Shop, Southwest Corner (Town of Halton Hills 2021)

Figure 35: Kirkpatrick Blacksmith Shop, Northeast Corner (Town of Halton Hills 2021)

Figure 36: Kirkpatrick Blacksmith Shop, Side (East) Elevation (Town of Halton Hills 2021)

Figure 37: Kirkpatrick Blacksmith Shop, Rear (South) Elevation (Town of Halton Hills 2021)

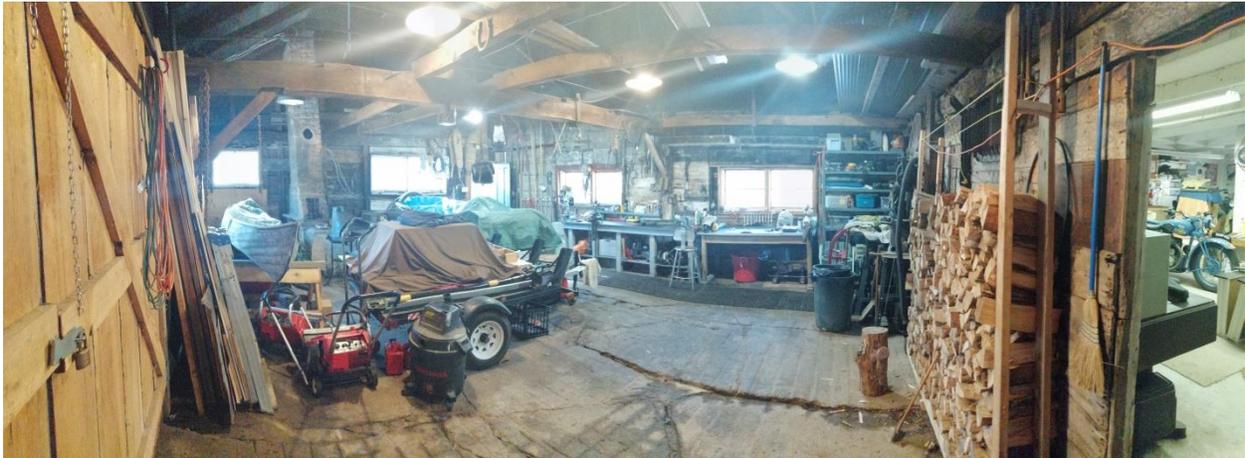
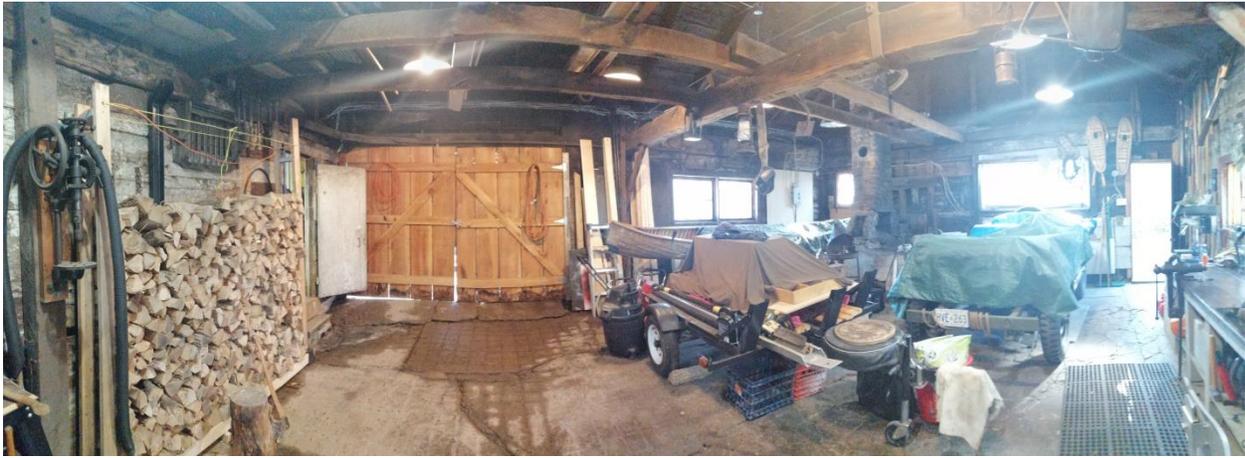
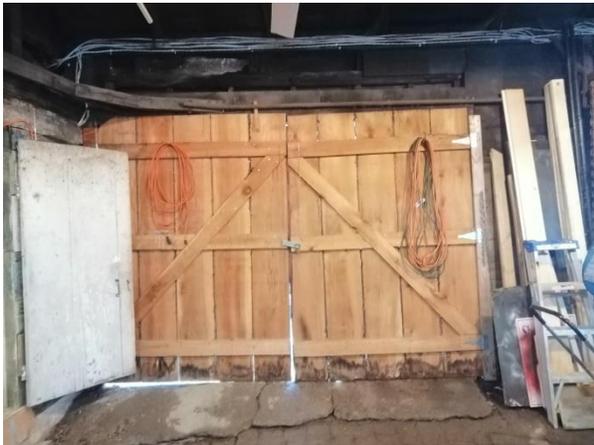
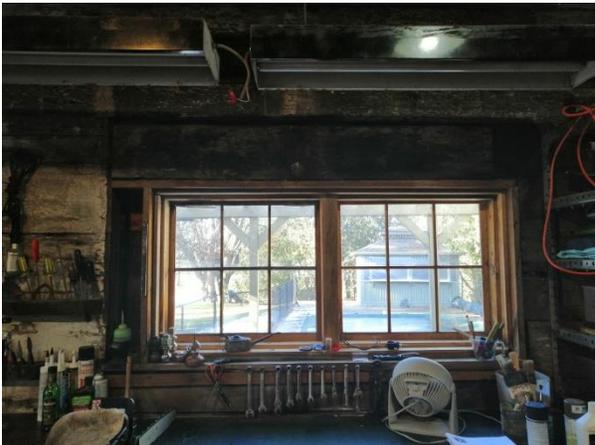
The interior of the blacksmith shop is divided into two spaces: the original blacksmith shop is located at the east end while a later addition is located at the west end. The interior of the original blacksmith shop (Figure 38 through Figure 45) contains many original features, including the original forge and interior portion of the chimney, stone floors, wooden beams, and whitewashed wood walls. Some alterations have been made over time to improve the structural integrity of the building, including additional roof support.

Figure 41: Kirkpatrick Blacksmith Shop - Interior looking east (Town of Halton Hills 2021)

Figure 38: Kirkpatrick Blacksmith Shop - Interior looking north (Town of Halton Hills 2021)

Figure 39: Kirkpatrick Blacksmith Shop, door opening looking north (Town of Halton Hills 2021)

Figure 40: Kirkpatrick Blacksmith Shop, window opening looking south (Town of Halton Hills 2021)

The west portion of the Kirkpatrick Blacksmith Shop, accessed via a step up from the original building, does not contain any significant features.

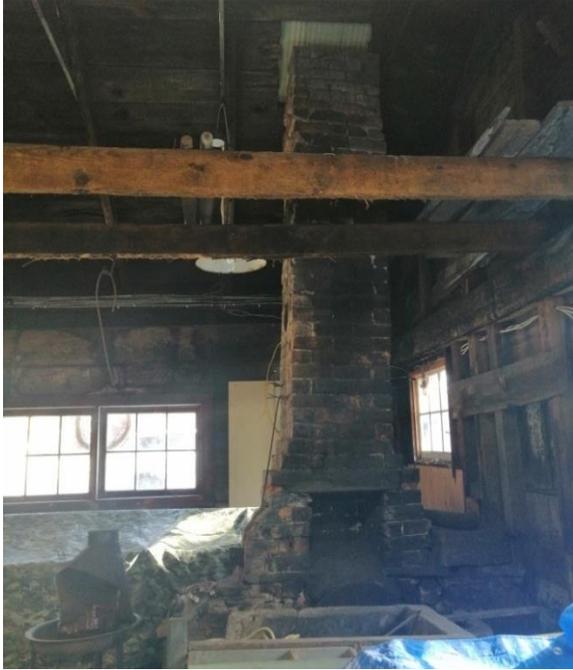
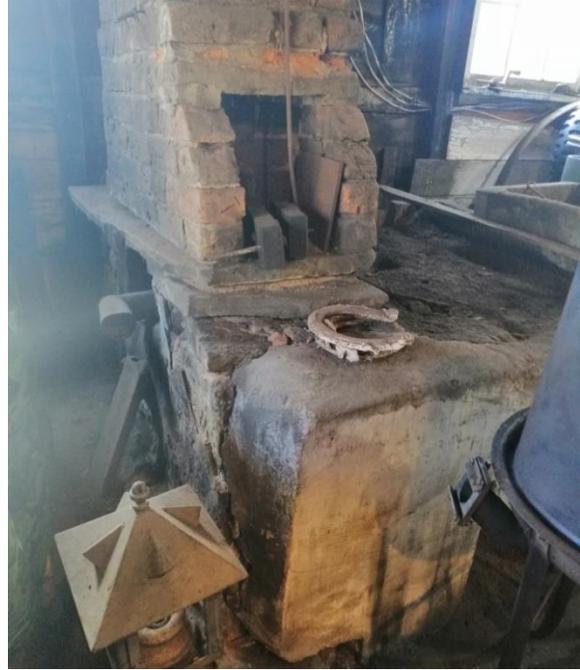
Figure 42: Kirkpatrick Blacksmith Shop, original forge, and chimney (Town of Halton Hills 2021)

Figure 43: Kirkpatrick Blacksmith Shop, original forge, and chimney (Town of Halton Hills 2021)

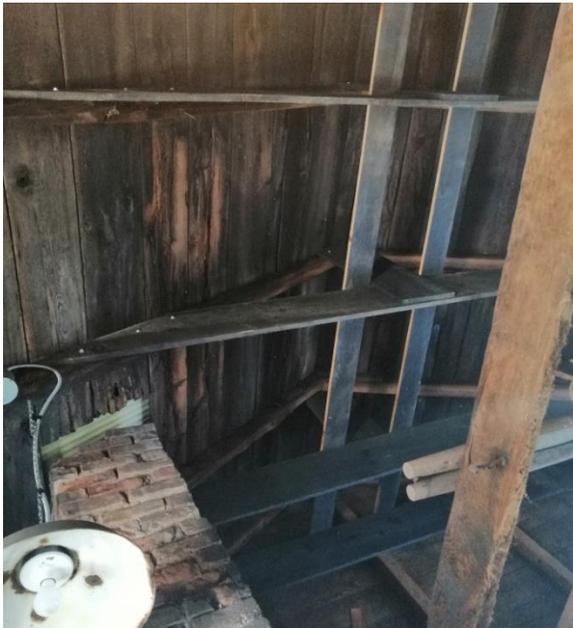
Figure 44: Kirkpatrick Blacksmith Shop, looking up at the rafters (Town of Halton Hills 2021)

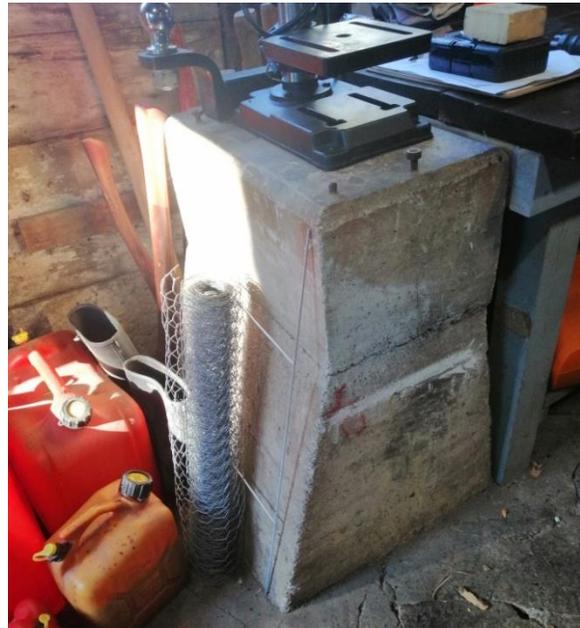
Figure 45: Kirkpatrick Blacksmith Shop, stone anvil (Town of Halton Hills 2021)
