# Research and Evaluation Report

## **The Old Armoury**

1 Park Avenue, Georgetown, Town of Halton Hills

June 2022

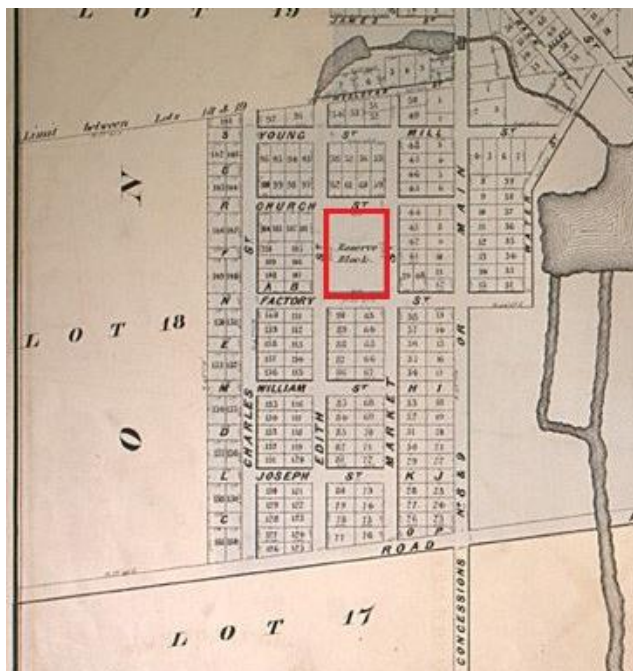
Figure 1: The Original Location of the Old Armoury prior to its move in the 1890s (County Atlas; Georgetown South Town Map)

The remaining land was then leased to the Department of National Defense in 1890 who used it as a training ground for the Halton Rifles. It was also around this time that the Georgetown Drill Shed was moved from its previous location at the Reserve Block at Church and Market Street in Georgetown to its current location.

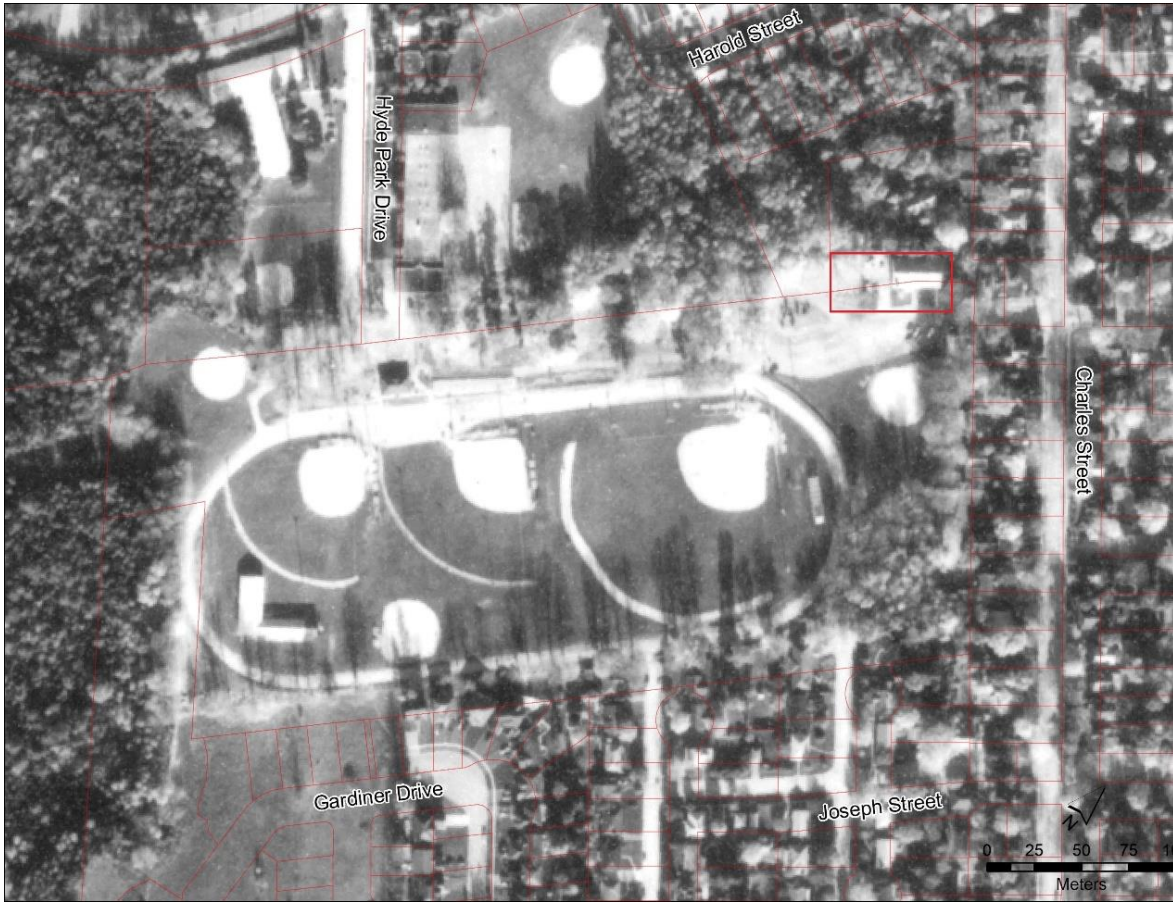
Figure 3: 1990 Aerial Photograph of the Georgetown Fairgrounds. The red outline indicates the location of the Armoury. (ArcGIS)

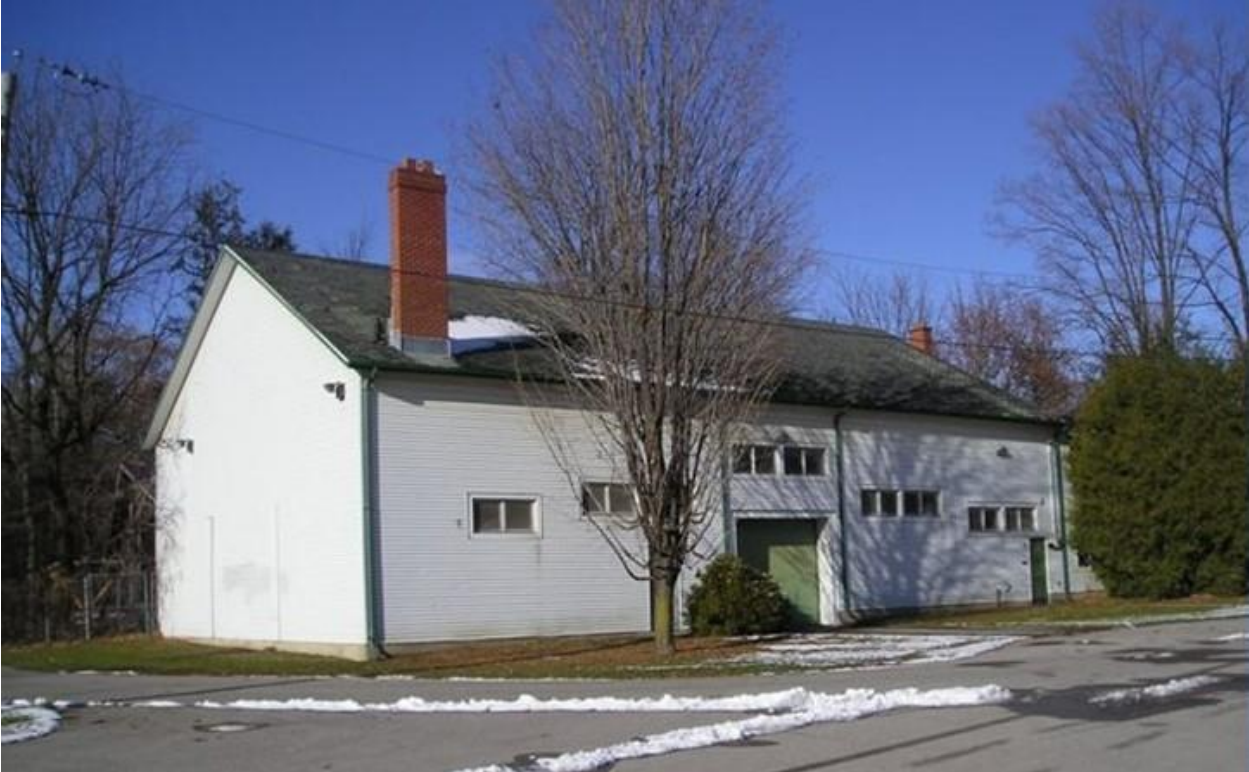
Figure 11: The Armoury in 2009 prior to the renovations. Photo Courtesy of Globe Productions

The Old Armoury was officially purchased by the Town of Halton Hills from the Department of National Defense on October 15, 1997. The old armoury was left abandoned for several years as the town attempted to find a new use for the building. In the interim, the building was mostly used as a fairground storage shed for equipment and fair displays during bad weather. The building's lack of use and neglect eventually led to the building falling into disrepair, leading the town to propose the building be scheduled for demolition.

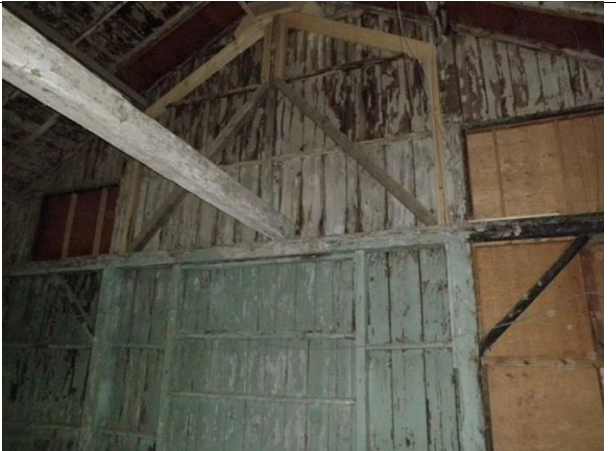
Figure 13: Interior of the Armoury prior to renovations. 2009. The original board-batten had been previously whitewashed and not maintained. Photo Courtesy of Globe Productions

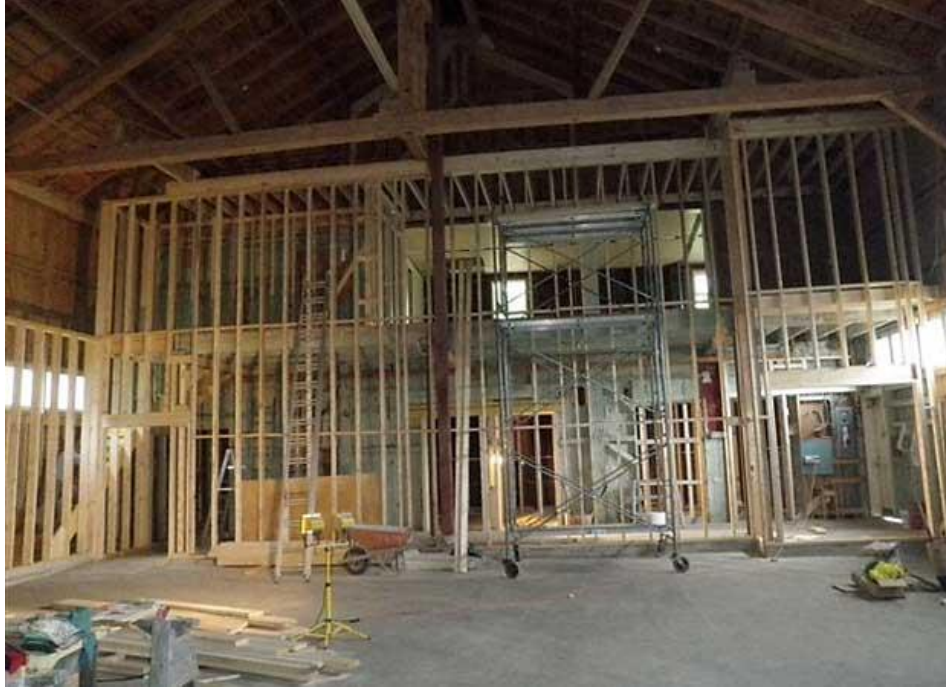
Figure 16: Interior Renovations, including the installation of new walls and stairs for new offices and second floor access. Date between 2010-2015. Image courtesy of Georgetown ON Magazine (georgetownon.ca)

Interior upgrades included the installation of insulation, drywall, electrical rewiring, energy-efficient heating and water systems, the inclusion of stairs to a second floor and an accessible washroom. Walls were constructed in the interior to create more space for a kitchen, bathrooms, and office and storage spaces.

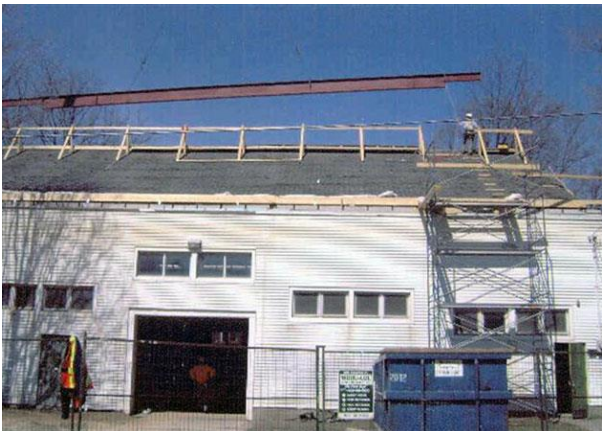
Figure 17: Roof reconstruction at the Old Armoury. Date between 2010-2015. Image Courtesy of Georgetown ON Magazine (georgetownon.ca)

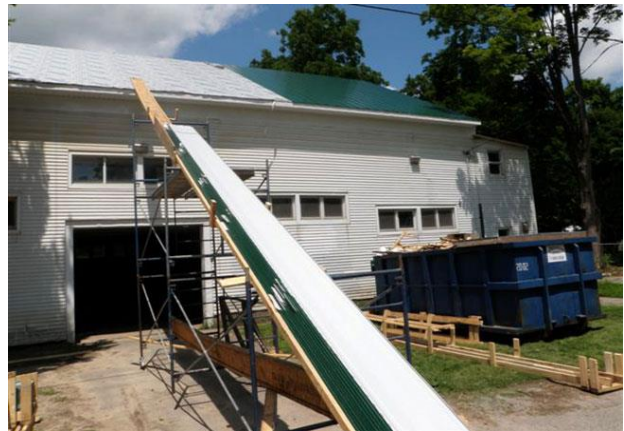
Figure 18: Old roof being replaced with green steel. Date between 2010-2015. Image courtesy of Georgetown ON Magazine (georgetownon.ca)

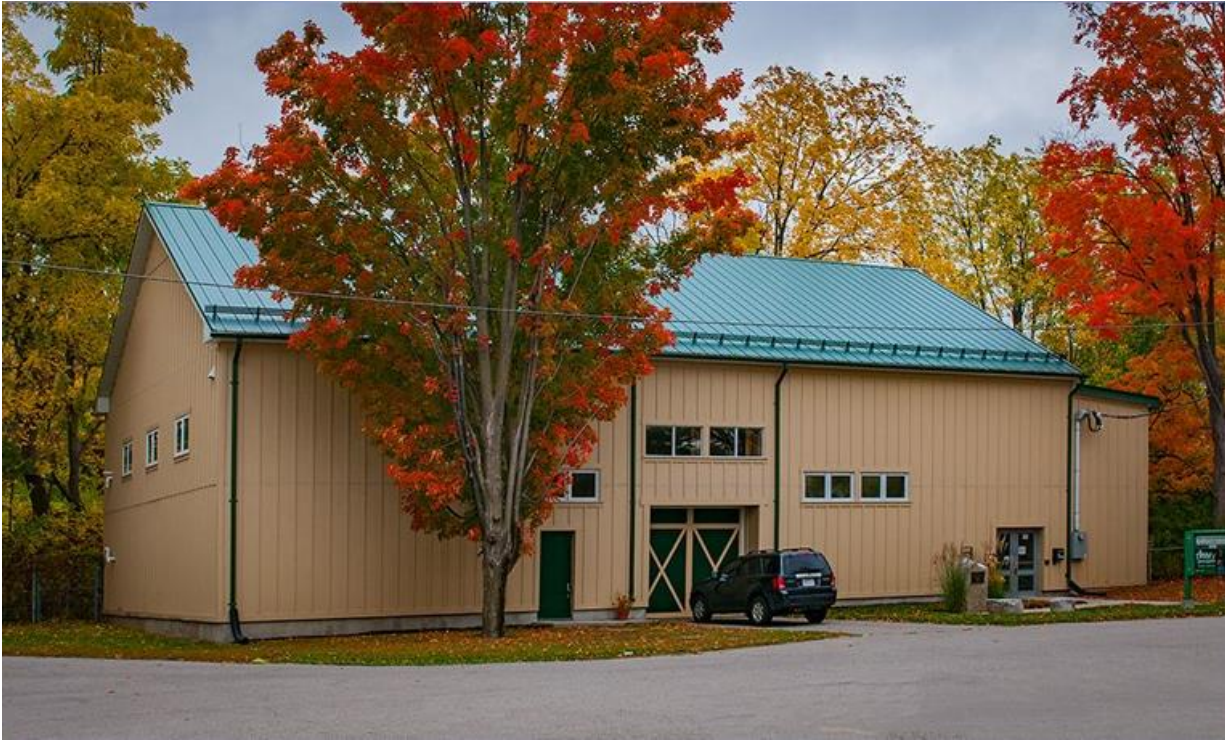
Figure 20: The Old Armoury in 2014 shortly after renovations were completed. Image courtesy of Globe Productions

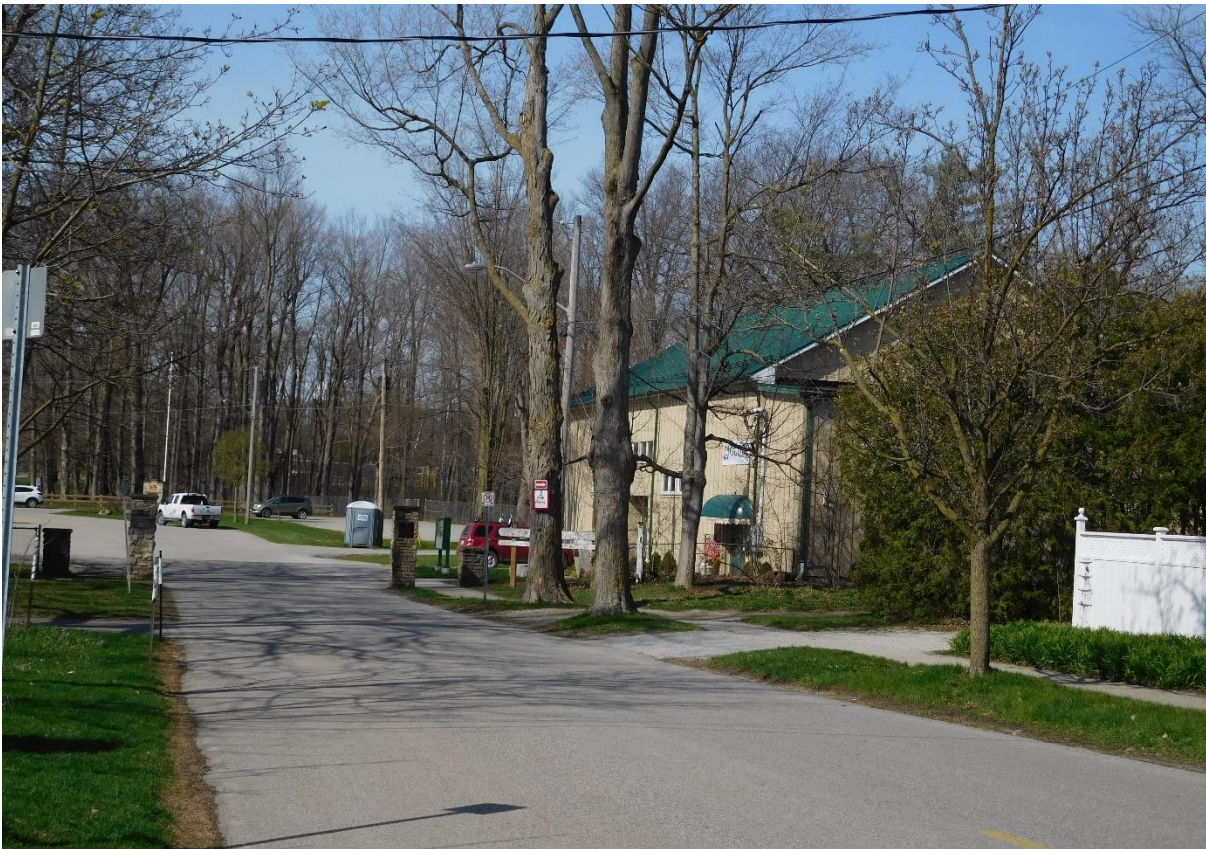
Figure 27: View of the Georgetown Old Armoury looking west from Park Avenue and Charles St. (Town of Halton Hills 2022)

The subject property is located at 1 Park Avenue, Georgetown, Halton Hills, and is a rectangular-shaped parcel situated at the northeast corner of the Georgetown Fairgrounds. The property is legally known as PT LT 18, CON 8 ESQ, PT 1, 20R12058; TOWN OF HALTON HILLS. The property is accessible via Park Avenue and is oriented to the southwest facing the parking lot of the Georgetown Fairgrounds.

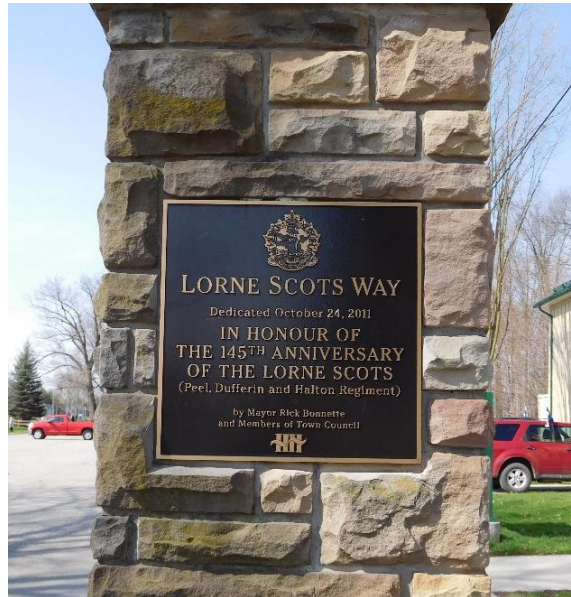
Figure 28: Bronze Plaque on the stone pillar at the entrance to the Fairgrounds (Town of Halton Hills 2022)

The Old Armoury building sits across from the Fairgrounds baseball diamond. The driveway to enter the property is flanked by two masonry pillars, one featuring a bronze plaque. A pair of mature deciduous trees can be found on the right side of the driveway into the property.

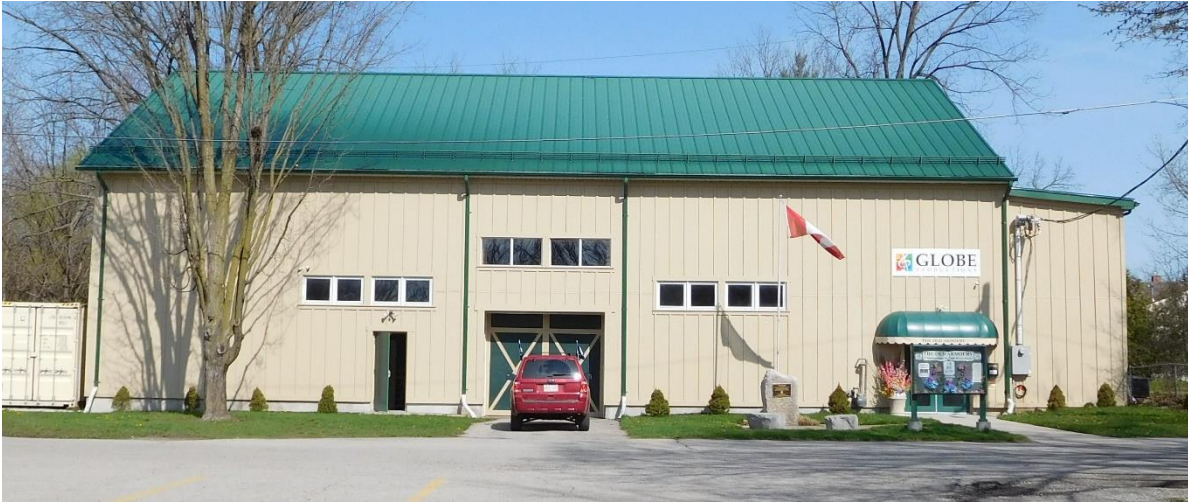
Figure 29: Front (Southeast Elevation) of the structure facing the Fairgrounds parking lot

A mature deciduous tree is located to the left of the building. The building features three doors on the south elevation of the property. The left door adjacent to the center entrance is a modern metal door that has been painted. The center entrance is a roll-up door painted in the style of a barn-door to mimic the original. The right entrance was modified as part of the 2010 renovations. The awning that overhangs the entrance that was added sometime after the initial renovations were completed.

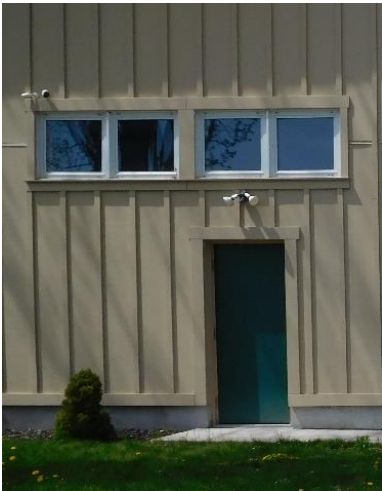
Figure 30: Side Entrance (Service Door) (Town of Halton Hills 2022)

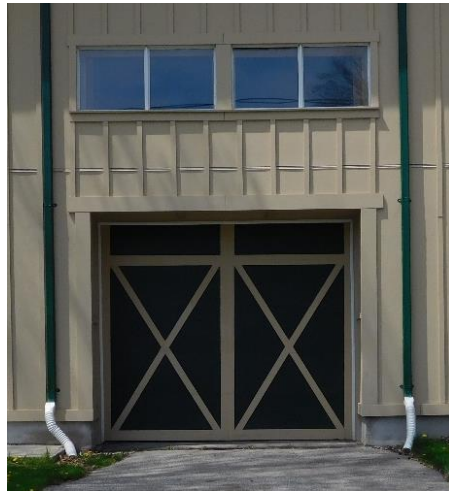
Figure 31: Central Entrance (Town of Halton Hills 2022)

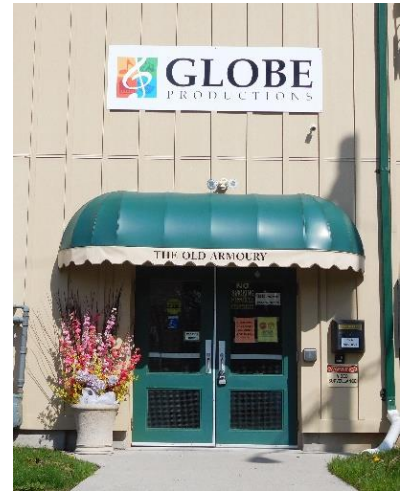
Figure 32: Visitor's Entrance; Double Doors (Town of Halton Hills 2022)

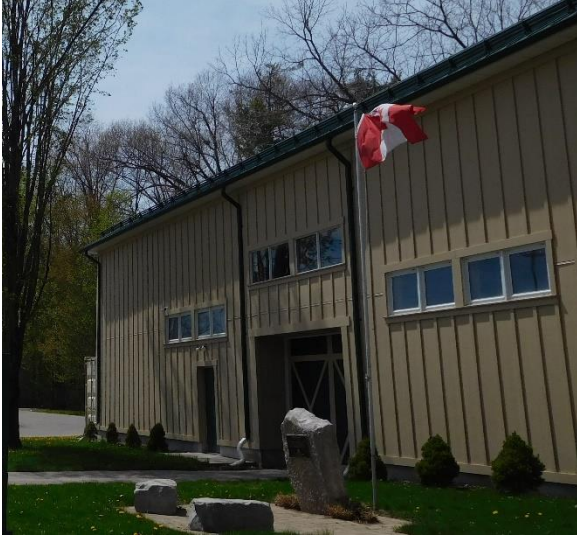
There are six pairs of vinyl double pane windows that are placed symmetrically over the central entrance.

Figure 33: Orientation of the double-pane windows on the front elevation (Town of Halton Hills 2022)

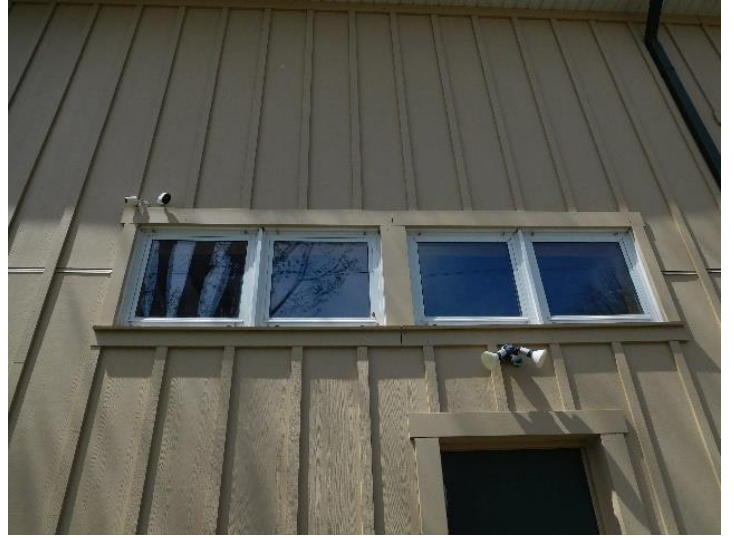
Figure 34: Detail of the double pane windows just above the side service entrance (Town of Halton Hills 2022)

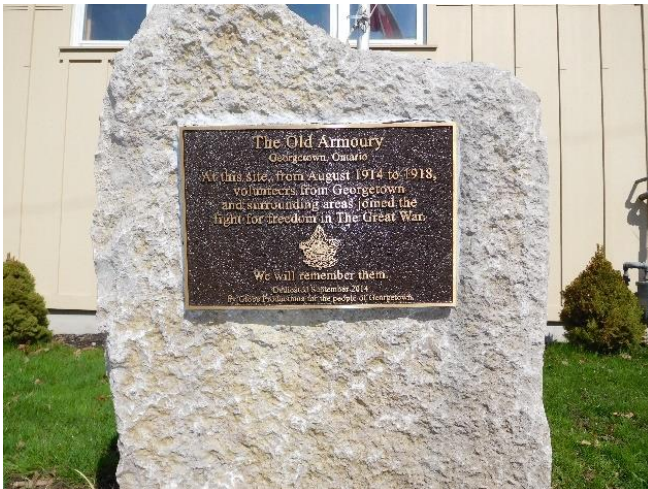
Figure 35: Stone Memorial with Bronze Plaque found just off the right entrance to the Armoury (Town of Halton Hills 2022)

A stone monument with a bronze plaque is placed to the left side of the main entrance facing the front parking lot between the barndoor entrance and main entrance.

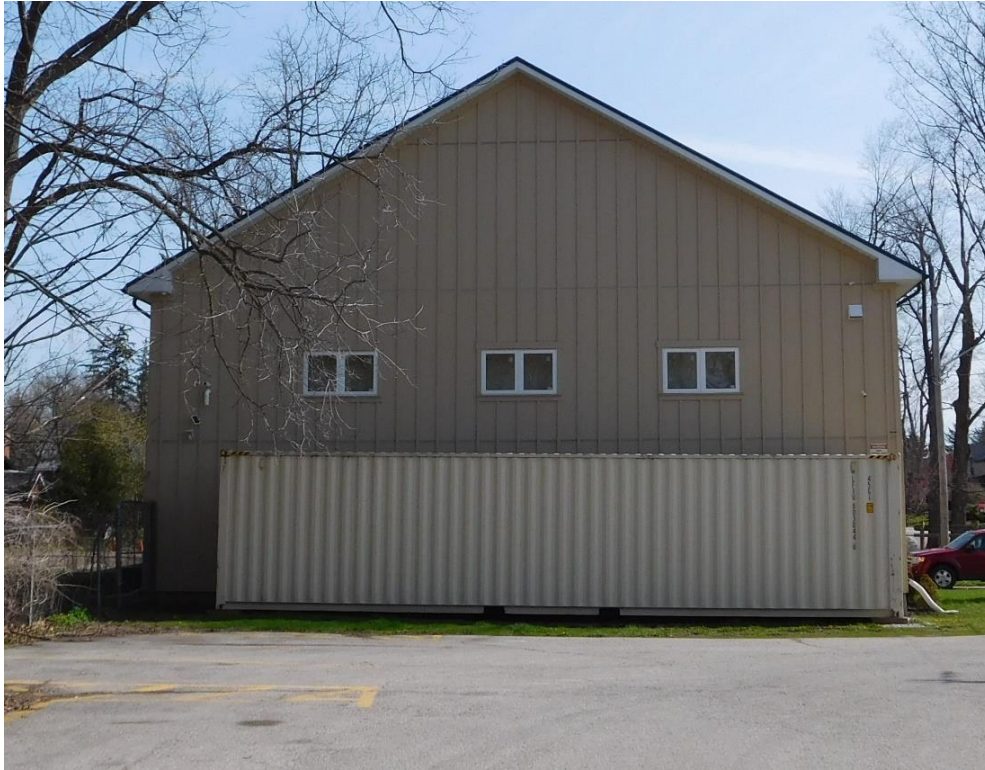
Figure 37: Side (Southeast) Elevation of the structure facing the southeast Fairground parking lot (Town of Halton Hills 2022)

The southeast elevation has three double-pane vinyl windows placed symmetrically towards the center of the elevation.

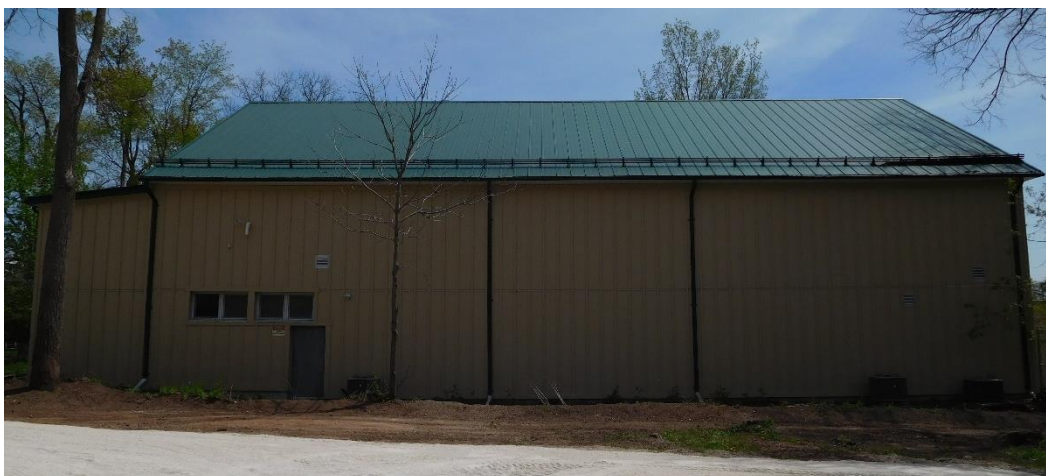
Figure 38: Rear (northwest) Elevation of the structure from 3 Park Avenue (Town of Halton Hills 2022)

The northwest elevation also has two double pane windows, placed just above a metal door off to the left side. There is no paved pathway along this elevation.

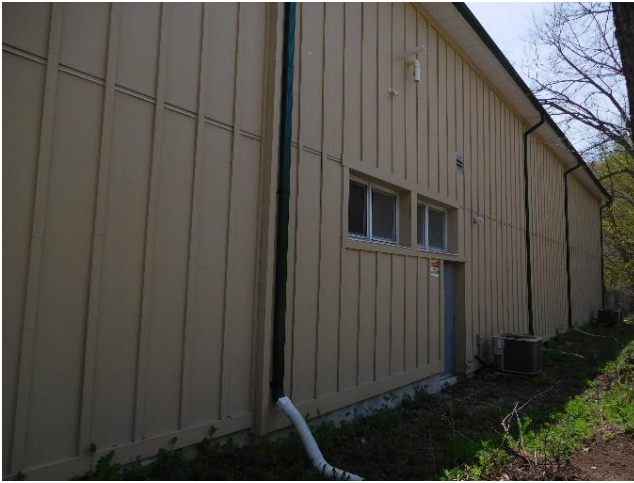
Figure 39: Orientation of the windows and door on the rear elevation (Town of Halton Hills 2022)

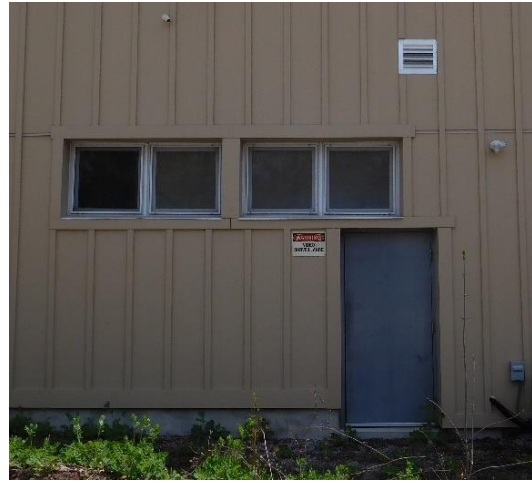
Figure 40: The door and windows on the rear elevation (Town of Halton Hills 2022)

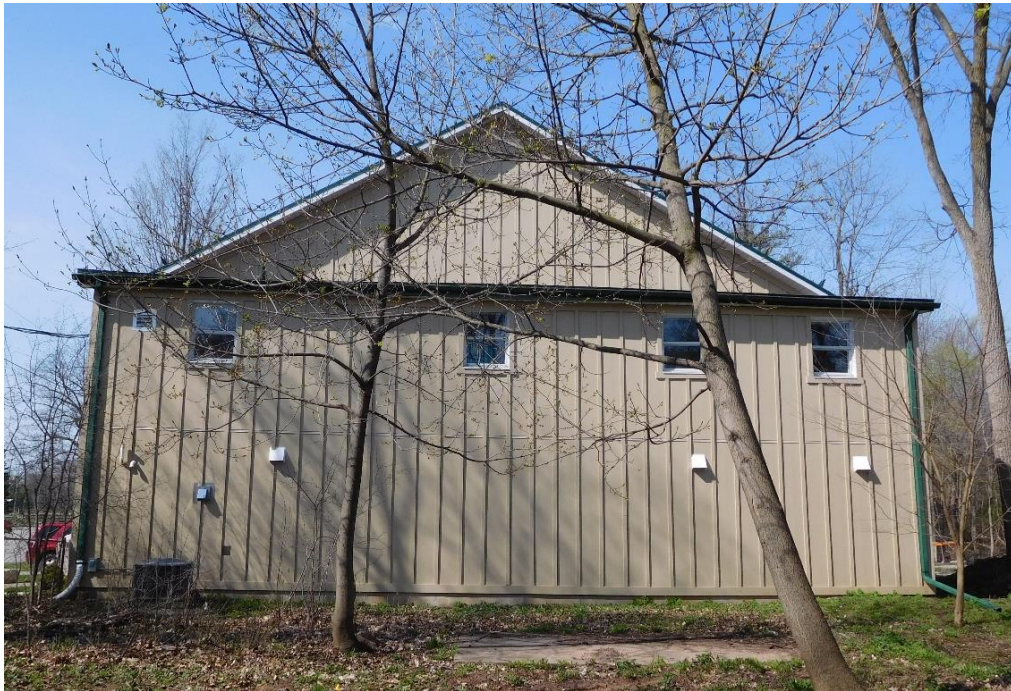
Figure 41: Side (Northeast) Elevation of the structure from the driveway of 3 Park Avenue (Town of Halton Hills 2022)

The northeast elevation has four double hung vinyl windows located just below the shed roof line. The shallow lean-to roof is located just below the lower edge of the gabled roof line.

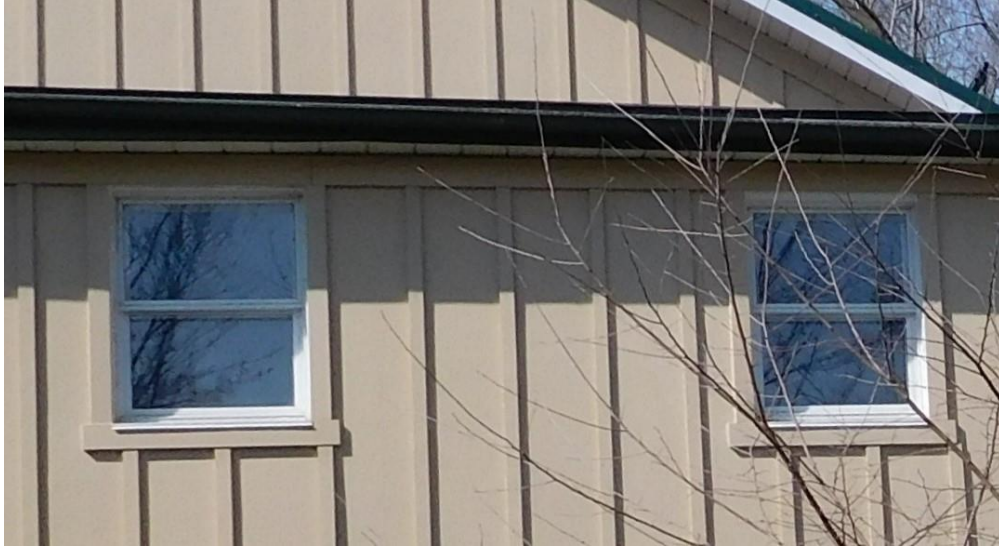
Figure 42: Double Hung Windows can be found on the northeast elevation of the Armoury building. (Town of Halton Hills 2022)

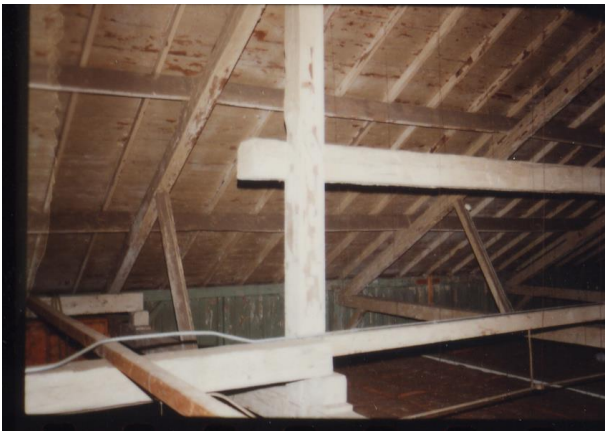
Figure 43: Photo of the roof trusses taken by the Department of National Defense. (EHS12567)

The interior of the structure was not accessible as of the finalization of this report. However, photos of the interior from the 1990s and early 2000s feature the roof trusses characteristic of drill sheds constructed during the 1860s. The interior walls also featured wooden paneling that covered the original wooden board-batten walls. These have since been removed during renovations in 2010.

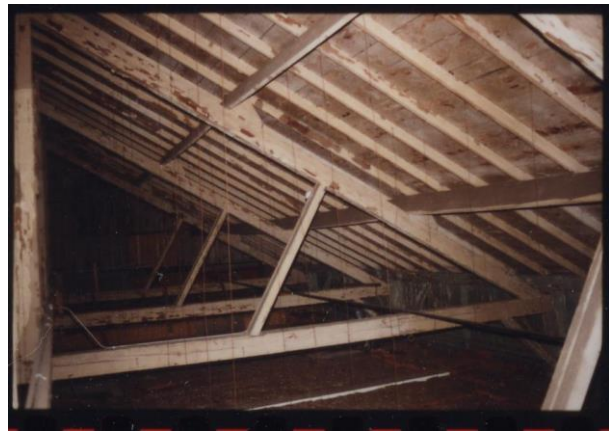
Figure 44: Photo of the roof trusses' structure. (EHS12554)

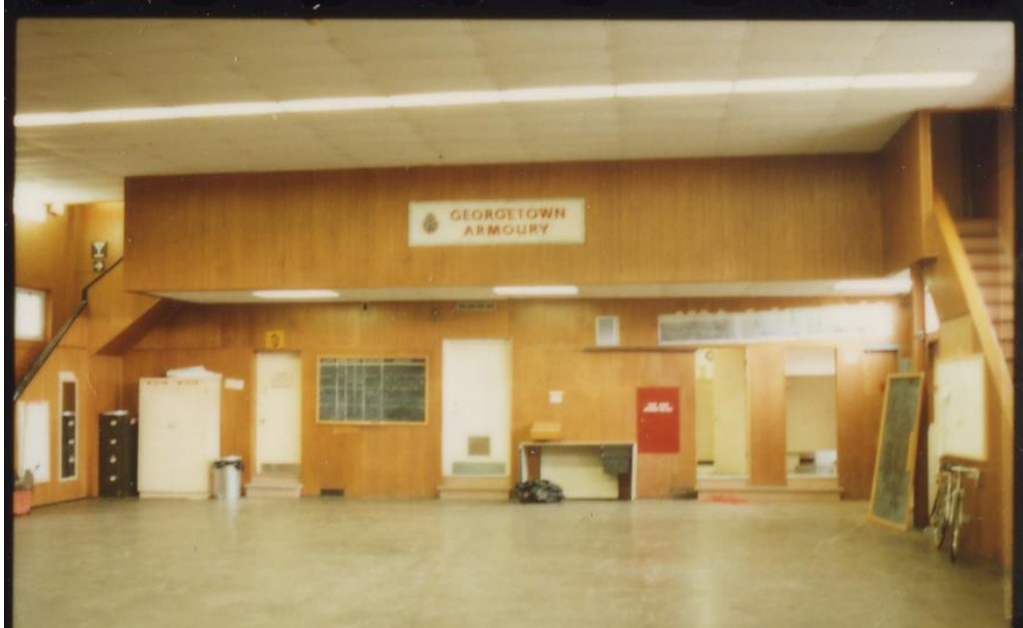
Figure 45: Main Room of the Drill Shed in 1990. (EHS12577)

There are also photos of the building shortly after the 2010 renovations were completed. The main room has since been restored its original board-batten walls and timber frame structure. The interior walls had been sandblasted to remove the whitewashing and to reveal the original wooden board-batten surface.

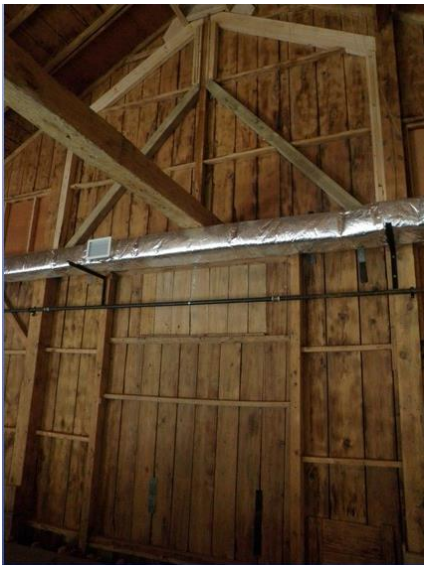
Figure 46: East interior wall of the main room of the Armoury. Image courtesy of Globe Productions

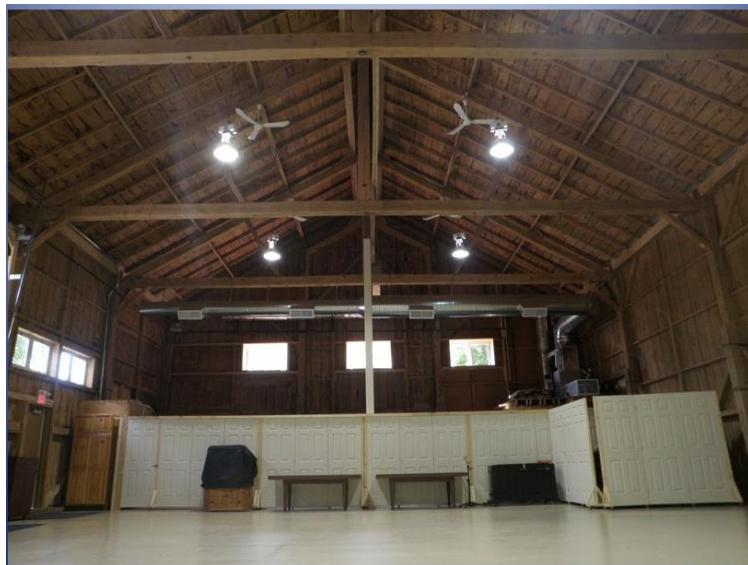
Figure 47: Restored main room of the Old Armoury in 2014. Image courtesy of Globe Productions

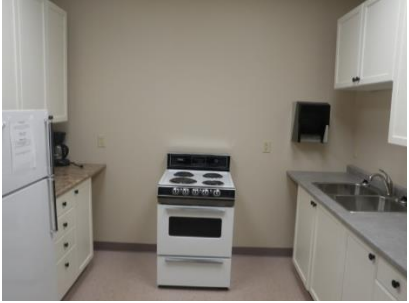
Figure 48: Newly installed kitchen. 2012.  
Image courtesy of Globe Productions

Additional walls have been installed to create more office spaces, production rooms, and amenities, including a small kitchen and public washrooms.

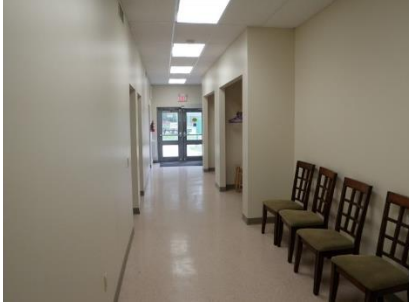
Figure 49: The new lobby hallway installed in 2010. Image courtesy of Globe Productions

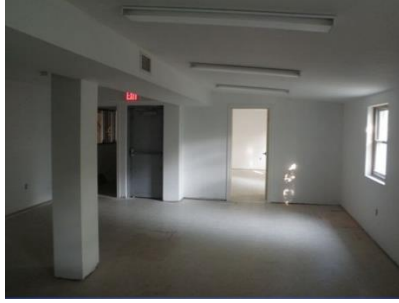
Figure 50: The renovated mess hall that has been converted into a costume room for theatre productions. 2012. Image courtesy of Globe Productions
