HERITAGE HALTON HILLS COMMITTEE AGENDA

Research and Evaluation Report

Limehouse Presbyterian Church

12418 Sixth Line, Limehouse, Town of Halton Hills

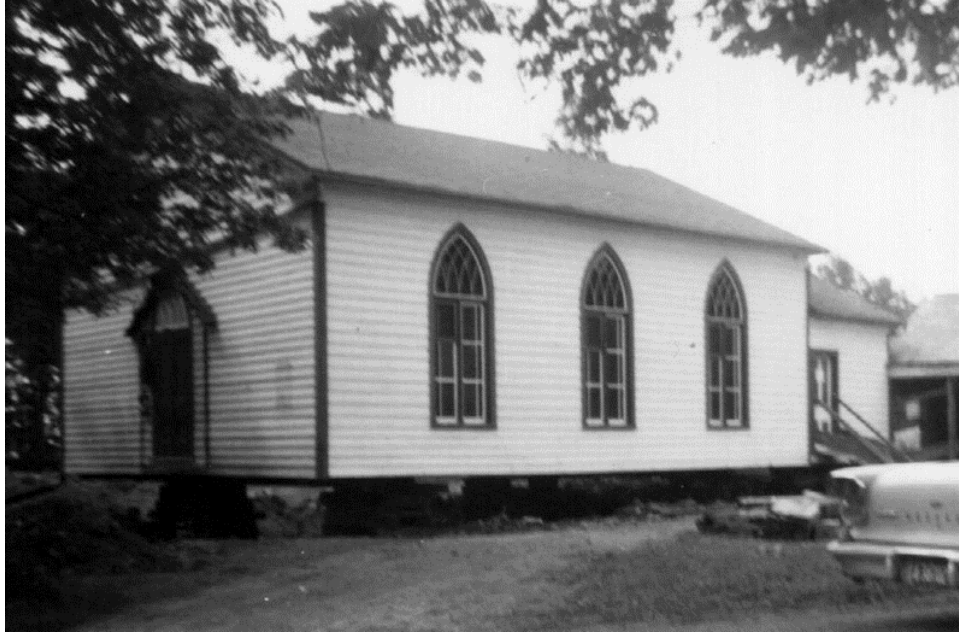
Figure 5: The church is raised on supports to dig out and construct the basement. The original doors remain in place inside the new front room (Brown 1961)

In 1961, the church was raised on temporary beams while the existing rubble stone foundation was removed and replaced with a full eight-foot-high basement wall made of concrete block under all three sections. This included an exterior exit as well as a stairway leading up to the new front vestibule which features a concrete floor laid with vinyl tile. Three small basement windows are centred under the tall windows above them on the north wall, while two windows are centred under the tall windows on the south side. The exterior exit and stairs are centred under the middle window. The front vestibule was designed by Sandy McKenzie of J.B. Mackenzie Lumber of Georgetown. The construction was done by the contractors Hawes and Nelson. The original doors remain on the opening into the sanctuary. The outside of the vestibule was covered in wood siding matching the original on the sanctuary.

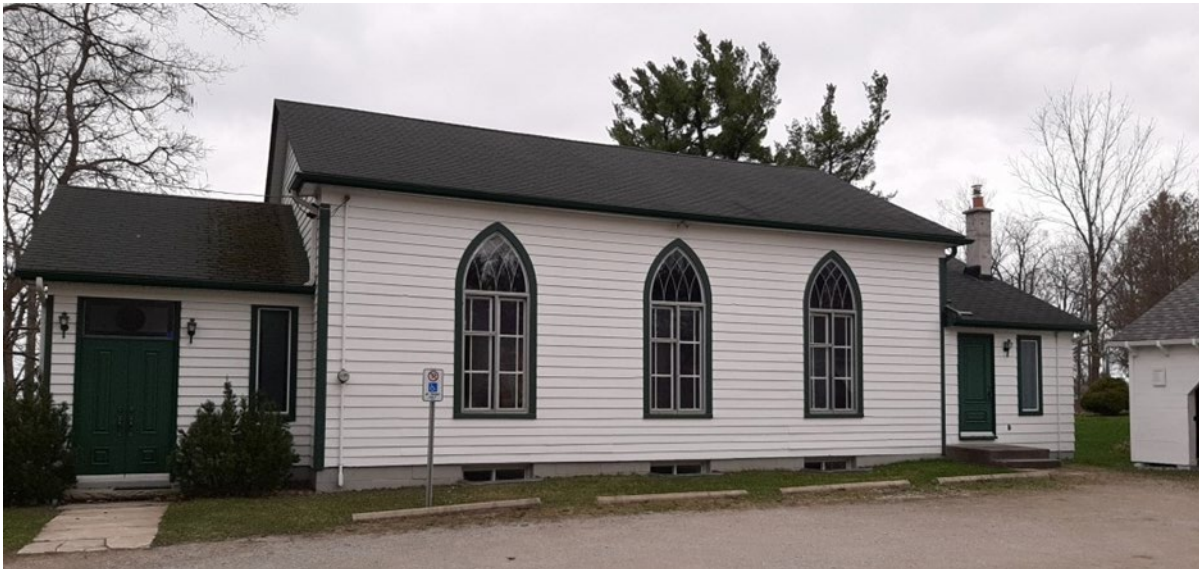
Figure 7: North side showing the three sections. L to R: front vestibule (entrance), sanctuary (original), back vestry with washrooms (Denny 2022)

The main roof and addition roof with asphalt shingles have a moderate twelve over seven or eight pitch with gable ends on the front and back. The structure is typical of rural churches and one room schoolhouses of the mid-nineteenth century with its single-storey construction with tall walls and ceilings. The flat ceiling inside the church is 13-feet high. The front and back rooms have regular eight-foot ceilings.

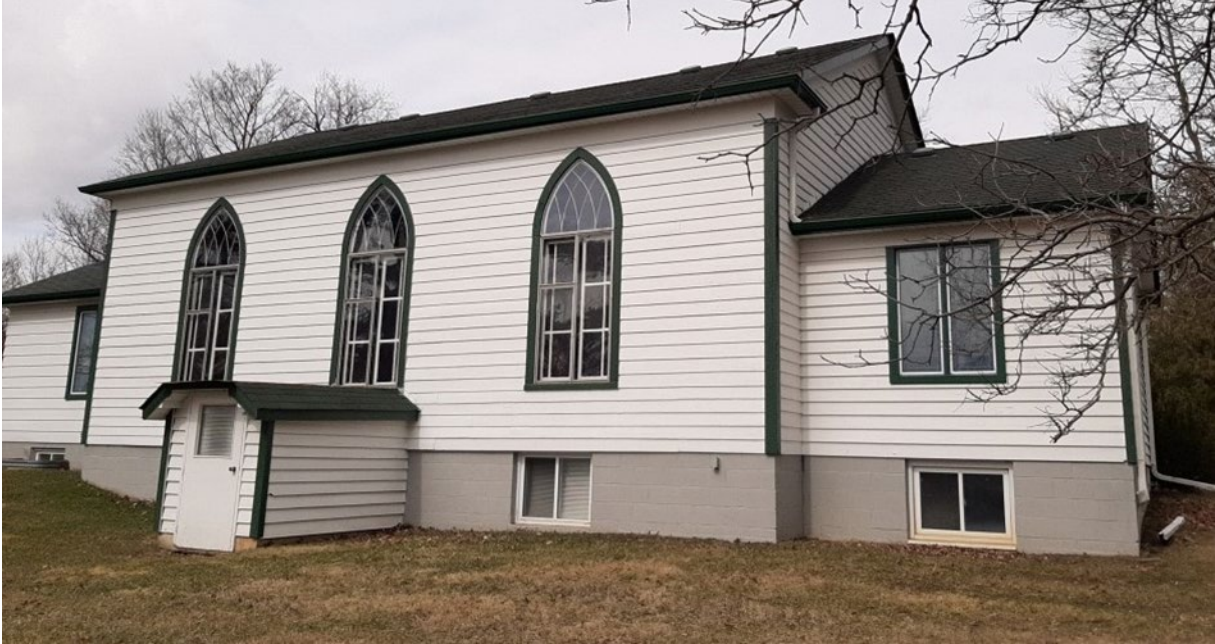
Figure 8: South side showing the main structure, additions, and exterior exit from the basement (Denny 2022)

The original building is post-and-beam construction with pegged mortise and tenon joints. The exterior walls of this sanctuary are covered with original seven-inch white painted wood siding, which may have been sourced from the Gowdy sawmill in Limehouse. Six-inch flat painted vertical boards are located at each corner of the main structure, and a twelve-inch bargeboard is located beneath the eaves. The roof features twelve-inch eaves with eave returns on the gable ends, while aluminum soffit, fascia, and eavestroughs cover the original wood construction.

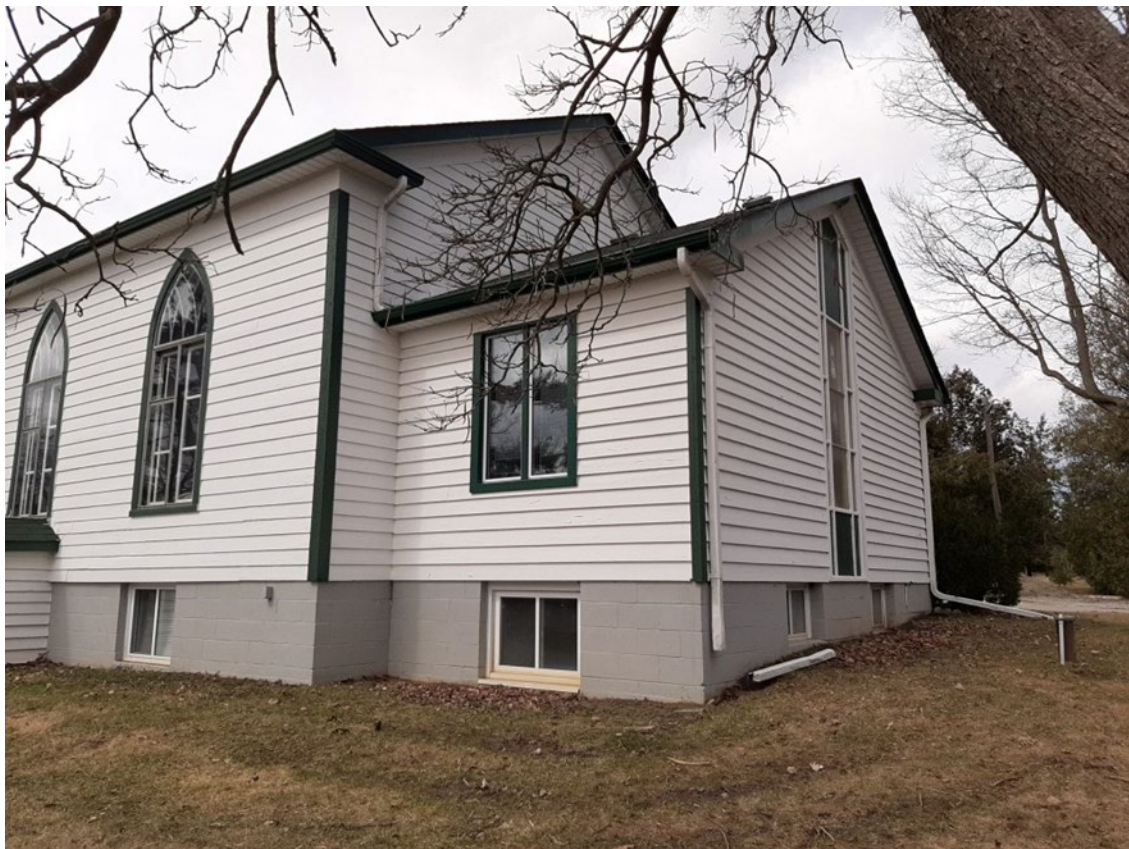
Figure 9: South-east side displaying basement and exterior features including eave returns, corner trim, gables, barge board and window placement (Denny 2022)

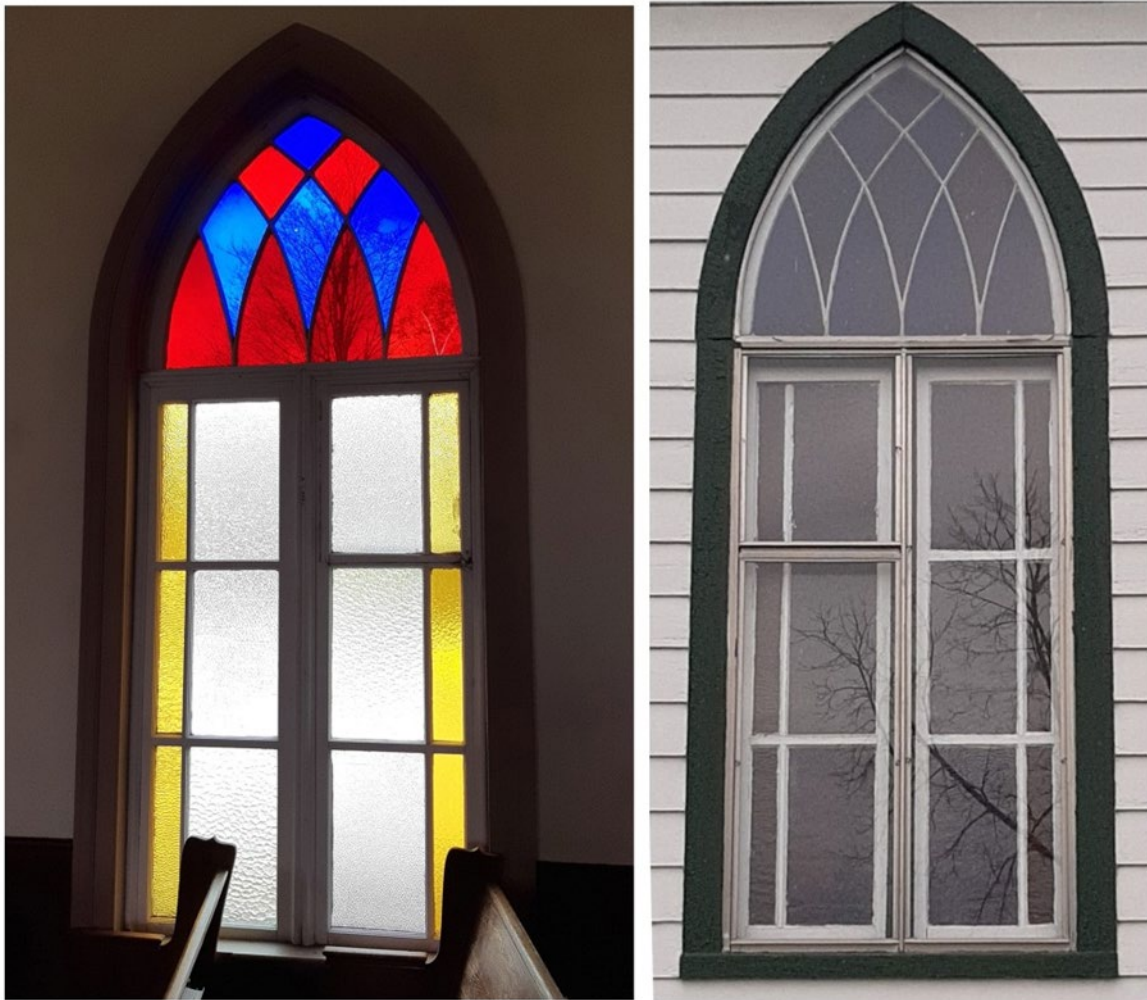
Figure 10: Inside view displays the rich colours and mullions, while aluminum storms protect the outside of the windows (Denny 2022)

The original pointed-arch windows are approximately four-and-a-half feet wide and ten-and-a-half feet tall. The rectangular portion of the window consists of three pairs of single pane pebbled clear translucent glass bordered with three pairs of gold translucent glass. One of the panels is hinged so it can be opened for air circulation. The top portion of the window consists of red and blue transparent glass laid out in a geometric design. The centre window on each side consists of the same red and blue glass but reversed in the colour pattern (**Error! Reference source not found.**). All the glass parts are held together with wooden mullions. The windows sit on a wooden sill and are trimmed outside with flat six-inch original wood, while the trim on the inside of the windows consists of slightly more elaborate moulded wood. The plain aluminum storm windows were likely installed in the 1960's.

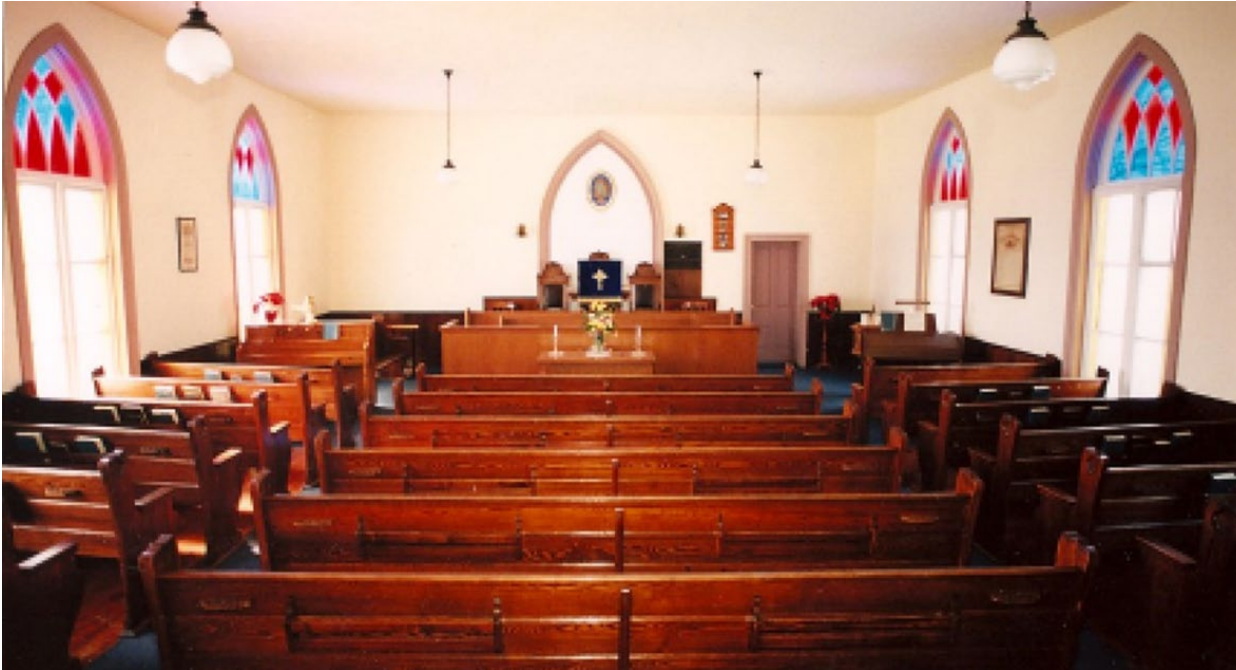
Figure 11: The alternating red and blue coloured window glass can be seen in this photo (2010 Brown)

The interior of the main building (sanctuary) consists of an open, undivided space. The side windows are located approximately eighteen inches off the floor, and a trimmed moulding feature at the front of the sanctuary matches size and shape of the windows. In the centre of the moulding feature is the Presbyterian symbol “the burning bush” painted by local artist Dorothy Stone in the 1960's. The walls and ceiling were re-plastered in 1964. Four original electric ceiling lights with white glass globes (c. 1930's) hang from chains from the ceiling. The original pine plank floors range in width from ten inches to twenty inches. Because they have been clear coated the grain and knots are very visible. Dark-panelled wood wainscoting is located around the entire room, however, is not original.

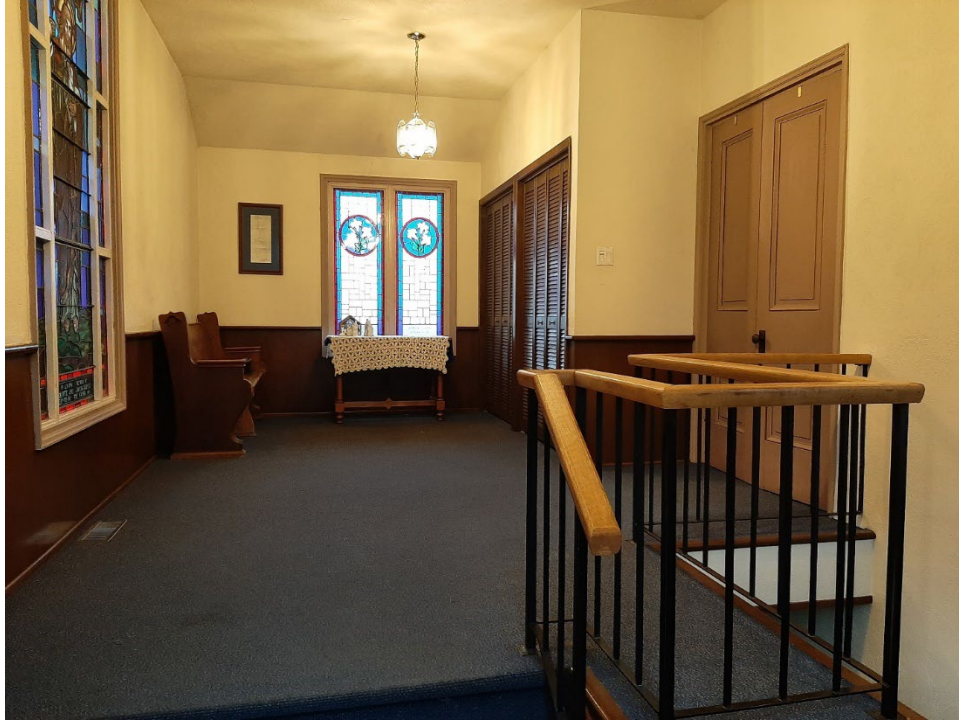
Figure 12: Front vestibule shows the stairs to the basement, original doors on the right, stain glass windows that have been added in the last forty years. (Denny 2022)

The stain glass windows on the sides and front of the front vestibule are recent additions from the 1980's and 1990's. The entrance double doors on the north side of this room are sympathetic to the historic architecture but are new steel doors. The original double doors and hardware that opened into the sanctuary remain but are enclosed by the front vestibule.

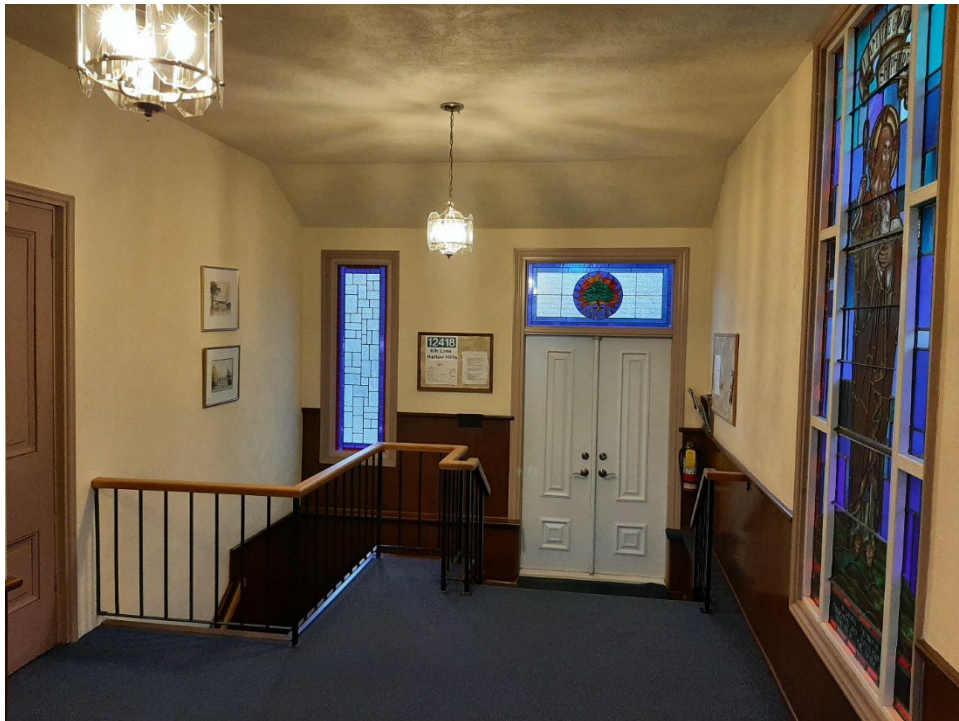
Figure 13: New steel entry doors with stain glass windows from the last two decades, (Denny 2022)

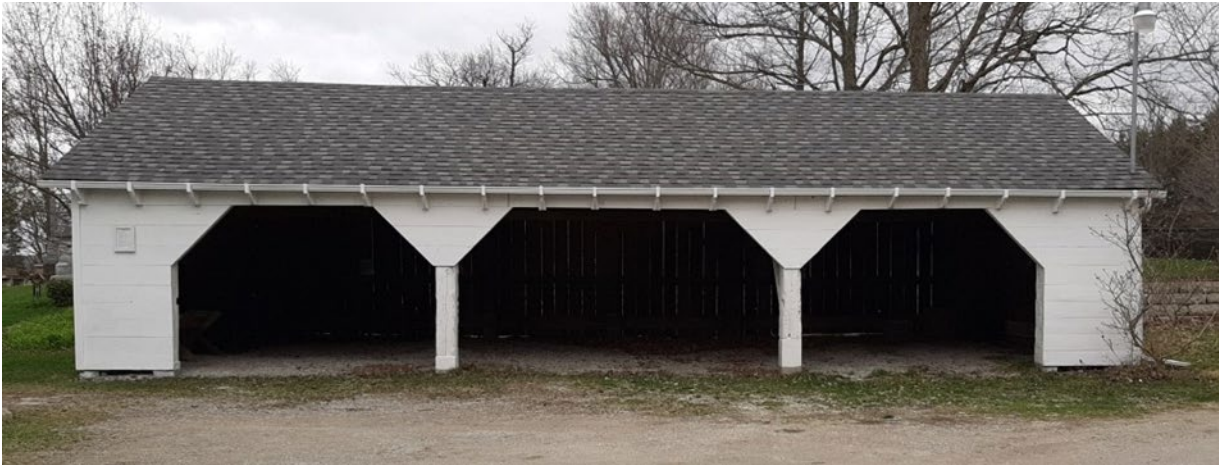
Figure 14: Front view of the shed facing northeast. (Denny 2022)

The shed adjacent to the church was originally built to protect the horses from the weather while the service was being held in the church (Figure 14). It was built after the church; however, the exact date of construction is unknown.

The shed is 45-feet long and 21½ feet deep. The exposed square poplar beams display pegged mortise and tenon joints. The corner posts and posts between the openings are approximately ten inches square, and all beams and posts display the hand-hewn markings of an adze or broad axe.

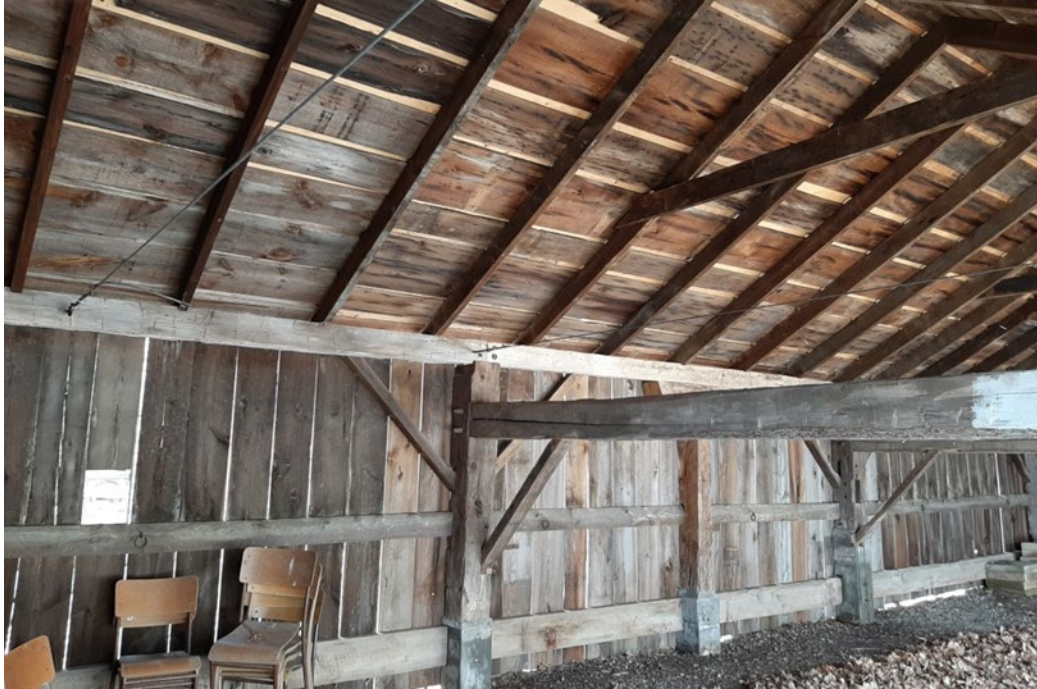
Figure 15: Traditional post and beam construction (Denny 2022)

Two 10x8 inch cross beams connect the front wall to the rear wall to provide strength to the middle of this long structure. These beams are low, about five-and-a-half feet above the gravel floor. All posts are supported with 4" x 48" diagonal braces mortised into the horizontal beams. The two plate beams at the top of the front and back walls were originally forty-five feet long. However, because of the damage caused by a huge falling pine tree slicing through the middle of the shed in a windstorm in 2020, the middle part of the beams has been replaced with historic poplar beams mortised and pegged into place.

The roof is supported by six-inch rafters set 32 inches apart and notched into the plate beams. The rafters are butt-jointed at the peak with no ridge plate. They extend about ten inches beyond the walls on the gable ends and about six inches on the front and back. There is no fascia, however aluminum eavestrough has been added to the front of the shed using wooden brackets to support it. The roof boards vary in size from 10" to about 18", spaced approximately one inch apart to allow for air ventilation for the original shakes, and are covered with plywood.

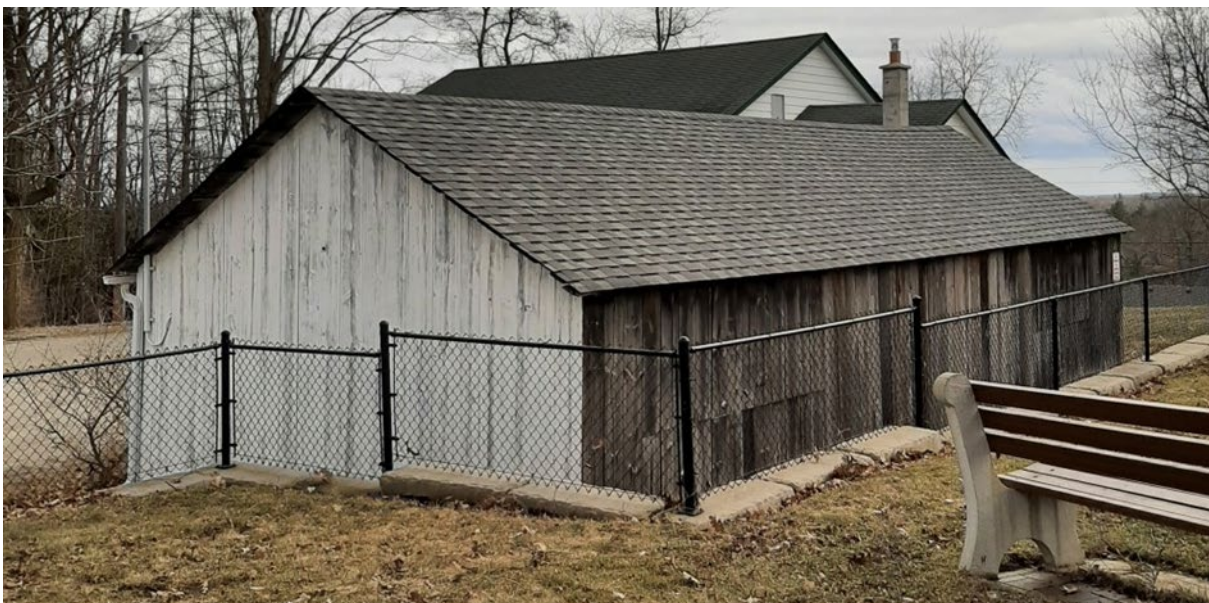
Figure 16: Northwest view of the horse shed, bordering on the cemetery (Denny 2022)

The shed has three, symmetrically placed rectangular openings with mitred top corners. The three openings are the same height, approximately seven feet, and the outer two have a width of 11 feet and the one in the middle is 14 feet wide.

The gable ends of the shed are covered with 10- to 12-inch-wide barn boards. The front of the shed has been covered with some rough lumber repairing the tree damage and earlier alterations made for an outhouse in the shed. The front and two ends are painted while the back boards remain weathered gray.

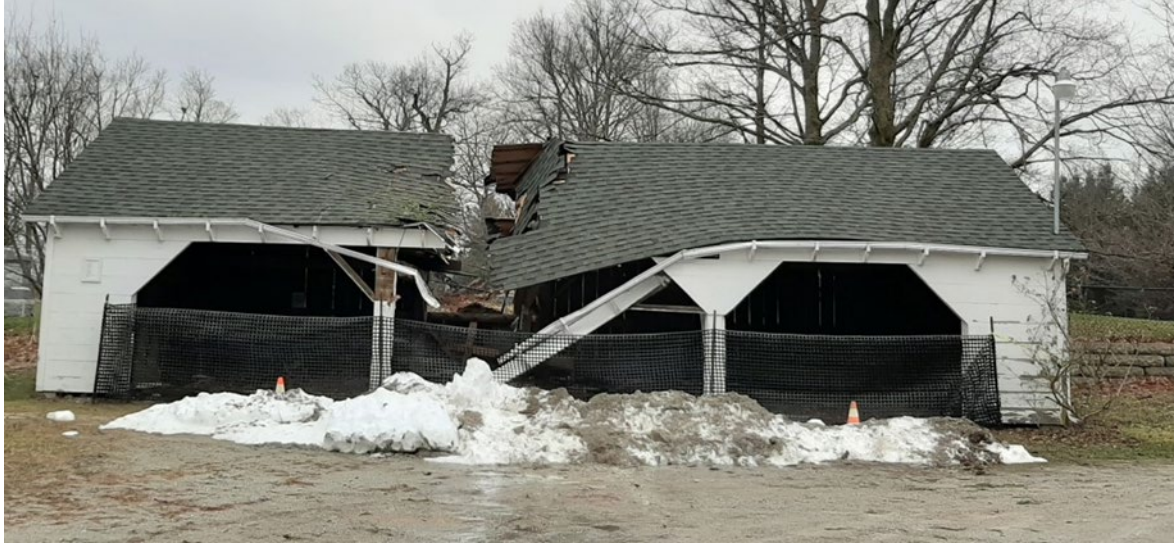
Figure 18: Tree damage from a storm on November 16, 2020 (Denny 2020)

In 2012, the shed was moved approximately eight feet from the church so the corner of the shed could be replaced. It had been altered to accommodate the new back room built onto the church in 1972. The shed was also raised several inches, and concrete piers were added beneath the posts. In 2021, the shed was repaired due to the extensive damage caused by the falling tree. All repairs were completed using historic techniques and reclaimed lumber.
