HERITAGE HALTON HILLS COMMITTEE AGENDA

Research and Evaluation Report

Harrison-Brown House

4 Stewarttown Road, Stewarttown, Town of Halton Hills

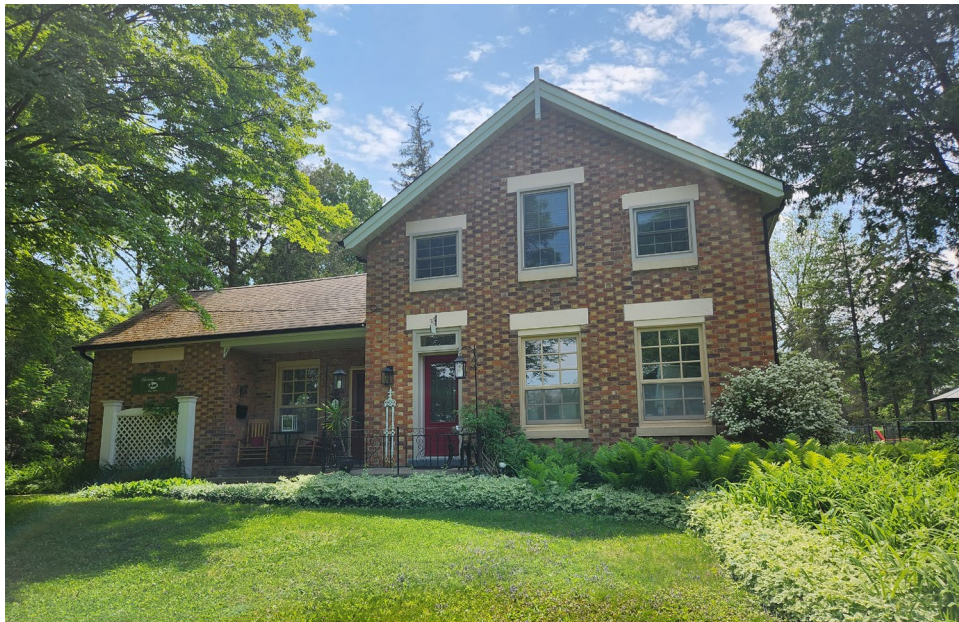
Figure 24: Front (southwest) elevation of existing residential buildings at 4 Stewarttown Road (Town of Halton Hills 2023)

The primary structure within the subject property is the existing residential building, which includes the original mid-nineteenth century structure and later additions to the rear of the property. The front (southwest) elevation of the building includes the one-and-a-half storey building with one-storey side wing, with a single entrance within the one-and-a-half storey portion as well as an additional entrance within a recess on the one-storey wing (Figure 21).

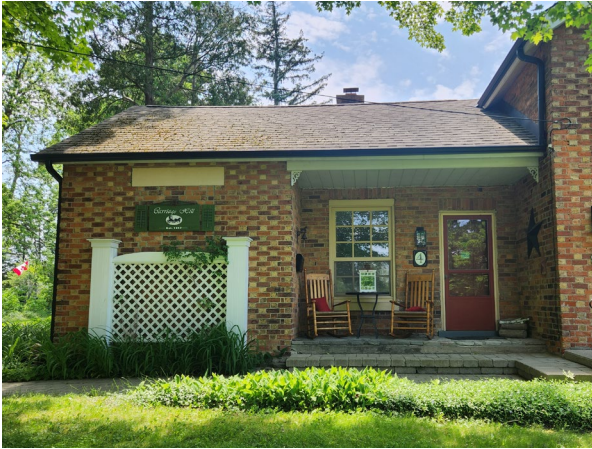
Figure 25: Partial front (northeast) elevation, 4 Stewarttown Road (Town of Halton Hills 2023)

The one-storey wing (Figure 25), likely an early summer kitchen addition to the original one-and-a-half storey structure, features the same red and buff dichromatic brick pattern, with some variation in colours throughout that would suggest the bricks used were produced at different times. A stone lintel (parged) suggests there was once a window opening on the projecting portion, while the flat-headed window opening and entrance within the recessed portion appear unaltered. Within the one-and-a-half storey portion (Figure 26), now-parged stone lintels are extant above the flat-headed door and window

openings, with stone sills on the lower windows at the first storey. Windows within the openings are not original. A decorative wooden element is located at the gable peak. Evidence of repair or alterations to the dichromatic brick are extant to the side of the entrance, suggesting brick may have been borrowed from other elevations as part of repair or alterations to the building.

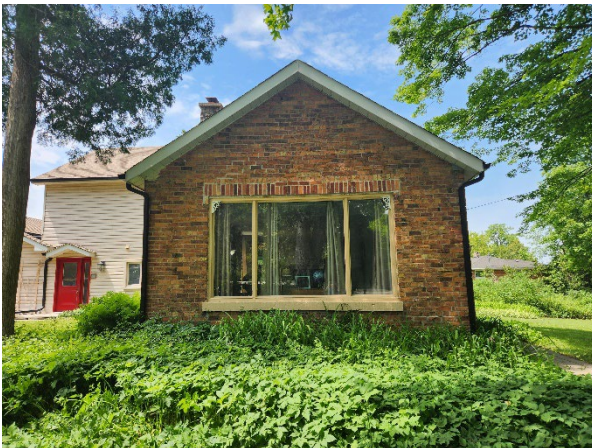
Figure 27: Partial side (southeast) elevation, 4 Stewarttown Road (Town of Halton Hills 2023)

The side elevation of the one-storey wing (Figure 27) features a large rectangular window opening, with clear indications within the brickwork above that the window opening has been altered over time. The rear elevation of the one-storey wing (Figure 28) features a flat-headed window opening and a stone chimney understood to be a more contemporary intervention.

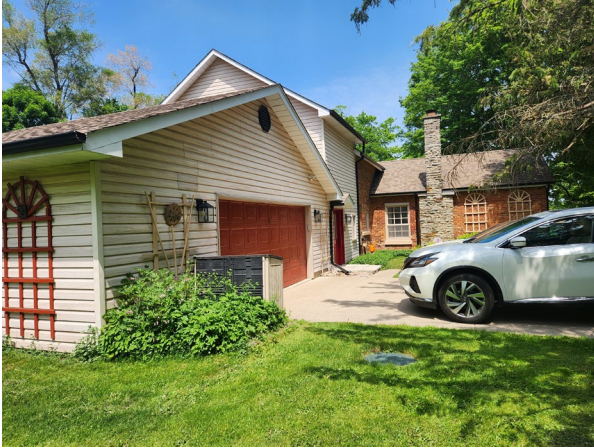
Figure 29: Looking towards the southeast elevation, 4 Stewarttown Road (Town of Halton Hills 2023)

A large gable-roofed addition with rear one-storey garage is located towards the rear of the building and was added to the property in the late twentieth century (Figure 29 and Figure 30) .

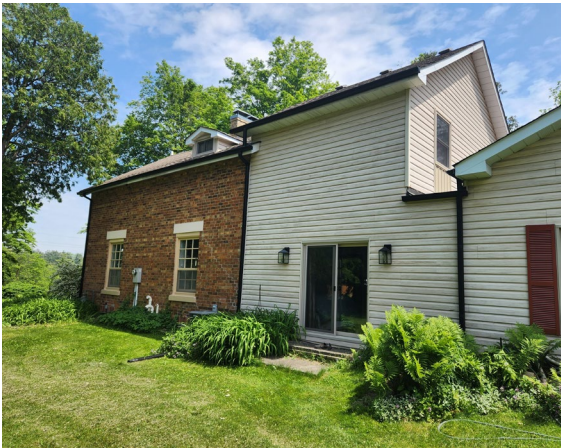
Figure 31: Looking towards the northwest elevation, 4 Stewarttown Road (Town of Halton Hills 2023)

The side (northwest) elevation of the original structure (Figure 31 and Figure 32) features the same dichromatic brick as the rest of the structure, with symmetrically-placed flat-headed window openings with stone sills and lintels that have been parged. A small gable-roofed dormer is located on the roof above and the central chimney (re-constructed above the roofline) is visible at the peak of the roof.

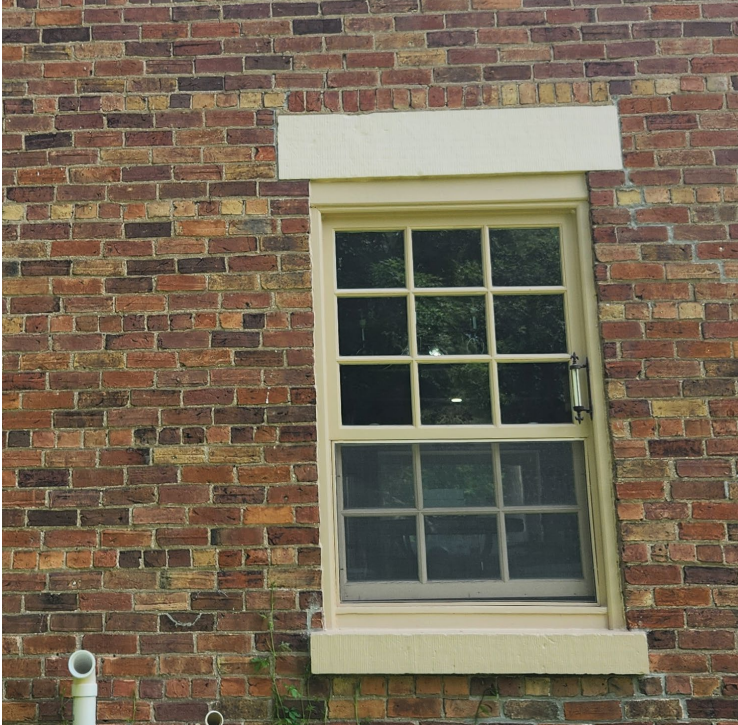
Figure 33: Detail of brick on northeast elevation, 4 Stewarttown Road (Town of Halton Hills 2023)

The dichromatic brick in a Flemish bond pattern throughout the original building features some variations in colour and texture, in line with it being hand-pressed and with alterations to the building understood to have taken place over time (Figure 33 through Figure 35).

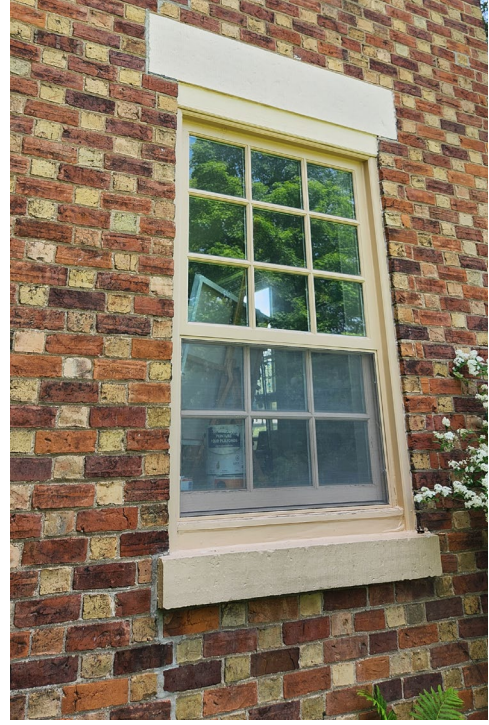
Figure 34: Detail of brickwork on front (southeast) elevation of original structure, 4 Stewarttown Road (Town of Halton Hills 2023)

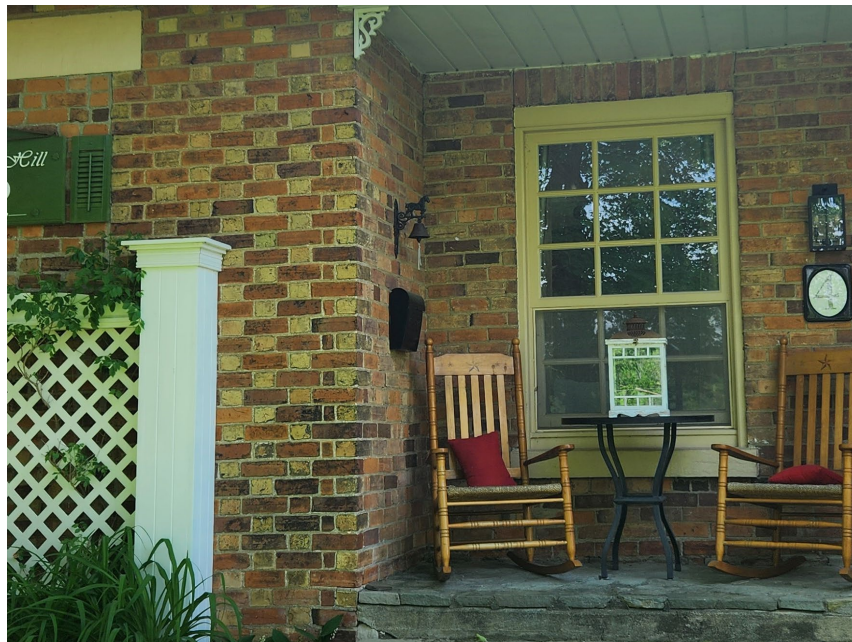
Figure 35: Detail of front (southeast) elevation, 4 Stewarttown Road (Town of Halton Hills 2023)

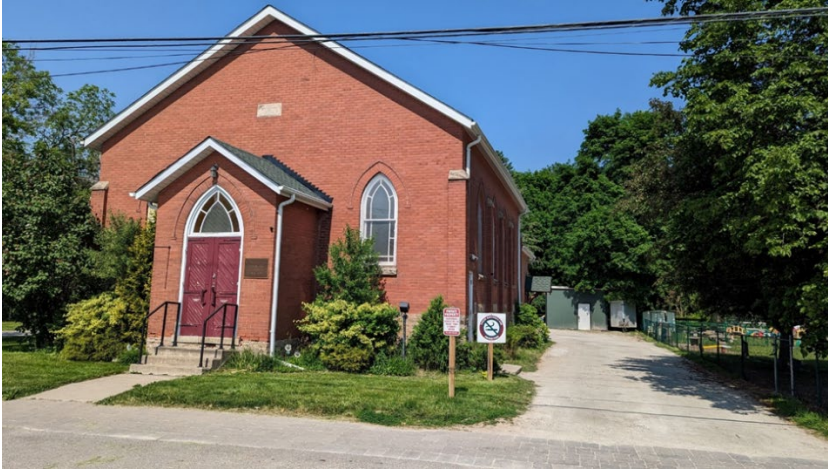
Figure 15: Village Montessori & Consulting, 533 Main Street, Glen Williams (J.M. Rowe June 2023)

The subject property contains a two-storey Gothic Revival frame Methodist Church built in 1840 and bricked over in 1903. The building functioned as a church from 1840 until 2021.

Today, the building has a low pitch asphalt shingle roof, a single step raised chancel, lancet windows and decorative buttresses, all elements characteristic of Ontario Gothic Revival churches.

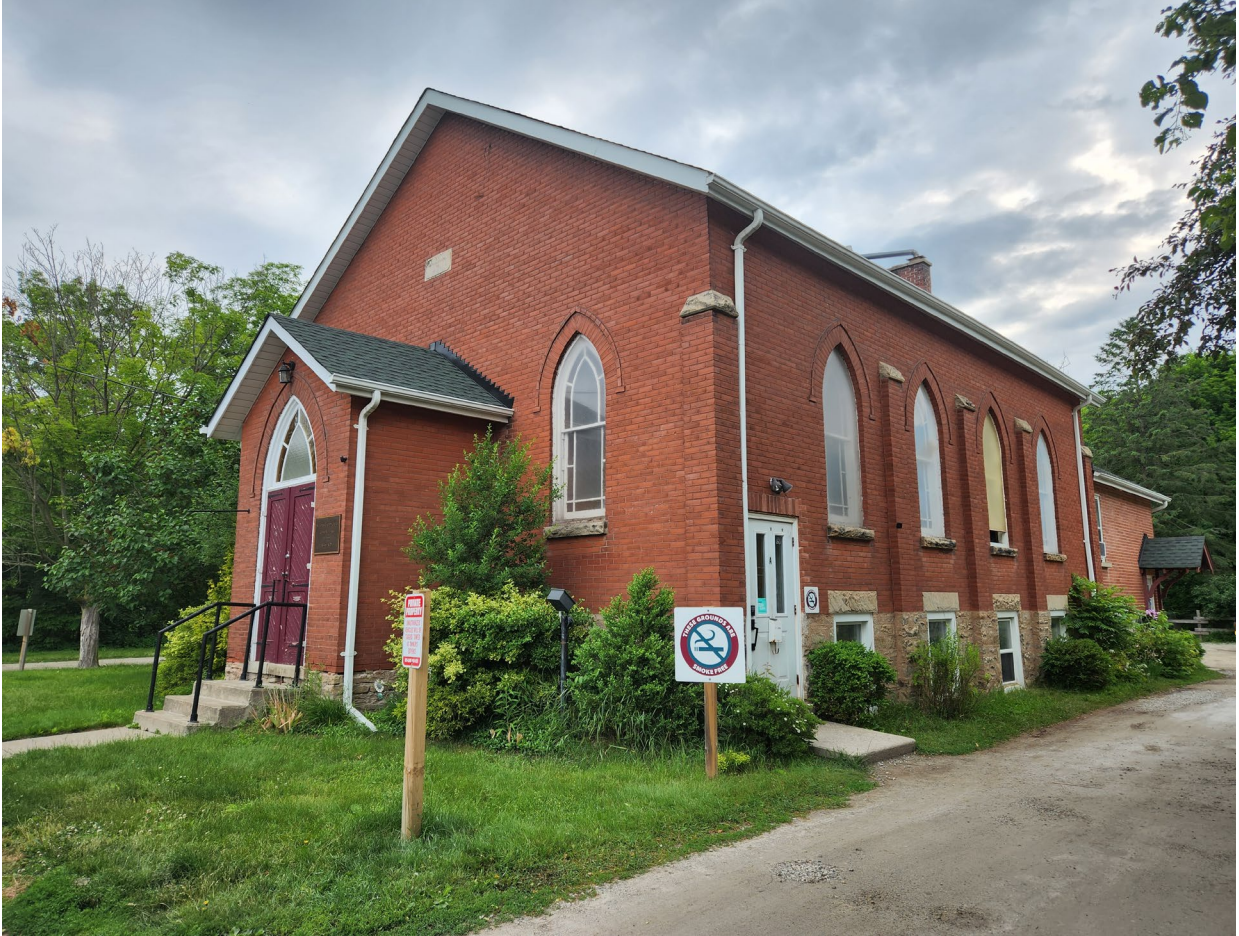
Figure 17: Looking northeast towards the existing building (Town of Halton Hills 2023)

The red brick façade has a tiny brick vestibule containing steps leading to the interior doors of the nave of the church. Exterior steps lead to the raised lancet arch entranceway with double wood strip rectangular doors. The top of the arch contains a transom in a simple tracery window, containing a central white pebbled glass and four outline sections of yellow pebbled glass. Above the frame of the arch doorway is a brick hood mould with straight label stops. A simple black lamp sits at the apex of the lancet arch doorway. A bronze plaque to the right of the doorway states, “St. John’s United Church, Glen Williams, Founded 1836 A.D.” A commemorative stone is set into the brickwork above the peak of the vestibule. It reads, “Glen Methodist Church A.D. 1837 & 1902.” (Figure 17)

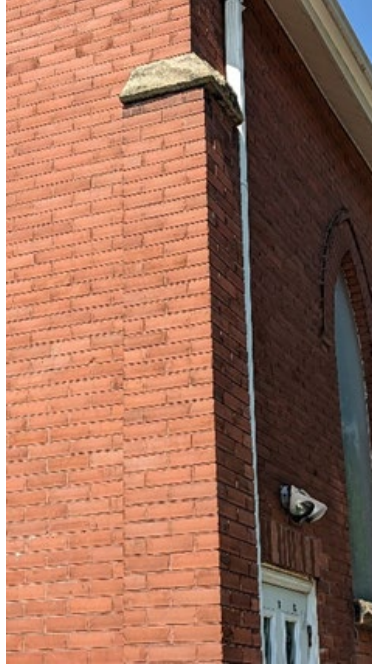
Figure 18: South-west corner buttress (J.M. Rowe June 2023)

On each corner is a brick buttress, capped with rough sandstone. The buttress continues in mortared field stone at the basement level.

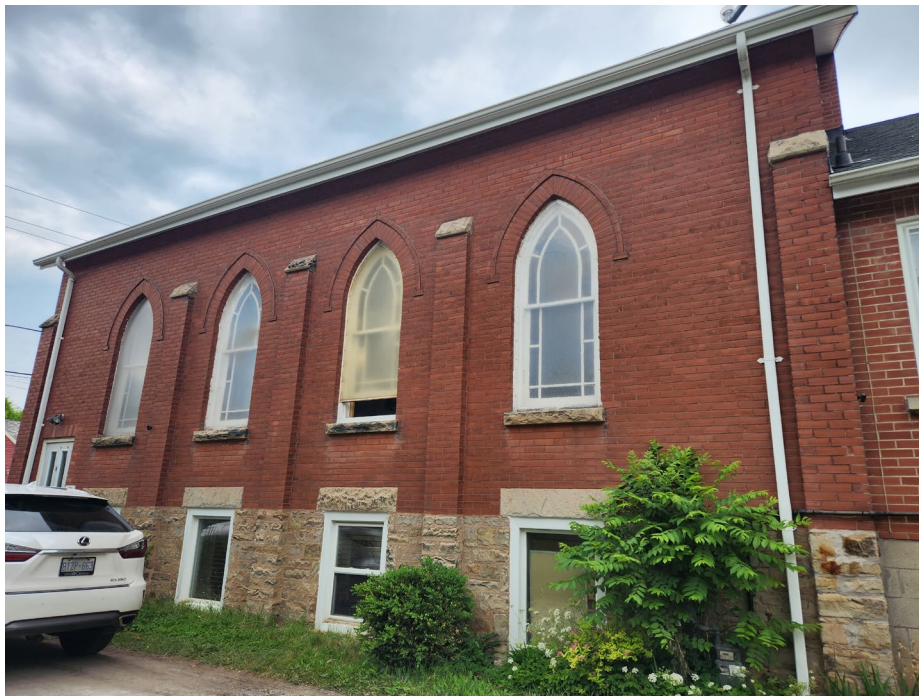
Figure 19: South elevation (Town of Halton Hills 2023)

On the south side of the building (Figure 19) are four arched lancet windows that match the front two. Four corresponding single hung sash windows are at ground level, for the basement. Each basement window is topped with a rough-finished sandstone header. Three brick and stone buttresses, matching the corners separate each window. The back corner of the original building also has a corner brick and stone buttress.

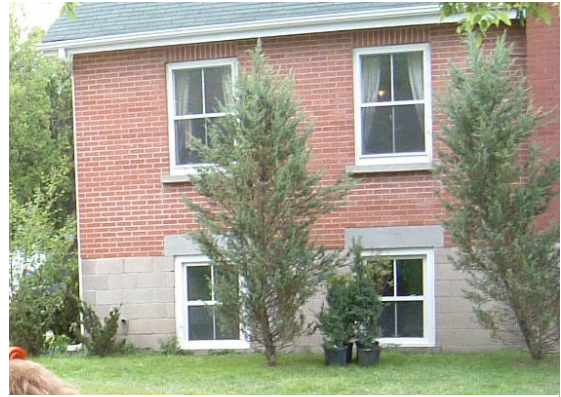
Figure 20: 2006 view of north side of the 1962 addition. J.M. Rowe photo

The 1962 red brick addition (Figure 20 and Figure 21) has two basement sash windows with a concrete block basement. The windows are topped by smooth stone headers. There is a single upper storey sash window. A modern steel door is fitted in the south-east corner, topped with a shingled wooden gable overhang.

The 1962 addition avoids the rear corner buttresses on both sides. The rear of the addition has three upper storey four-pane sash windows, while two windows serve at the basement level. The north-east side of the addition has two upper windows with two corresponding lower-level windows.

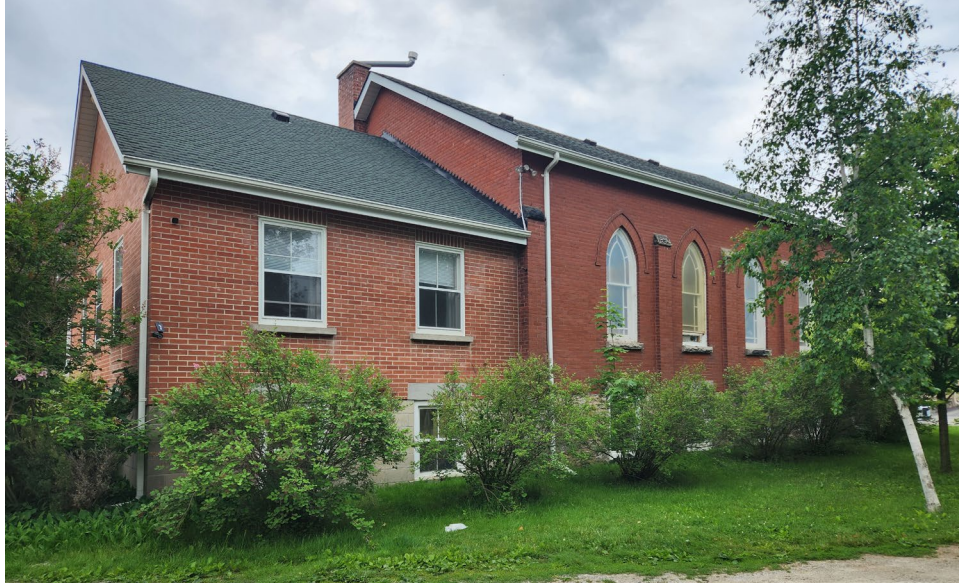
Figure 22: North elevation of 533 Main Street, Glen Williams, showing rear addition (Town of Halton Hills 2023)

The north side of the original church has the same four arched lancet windows with four corresponding lower windows as the south side. The buttress placement – each corner and three between the windows, matches the south side (Figure 22).

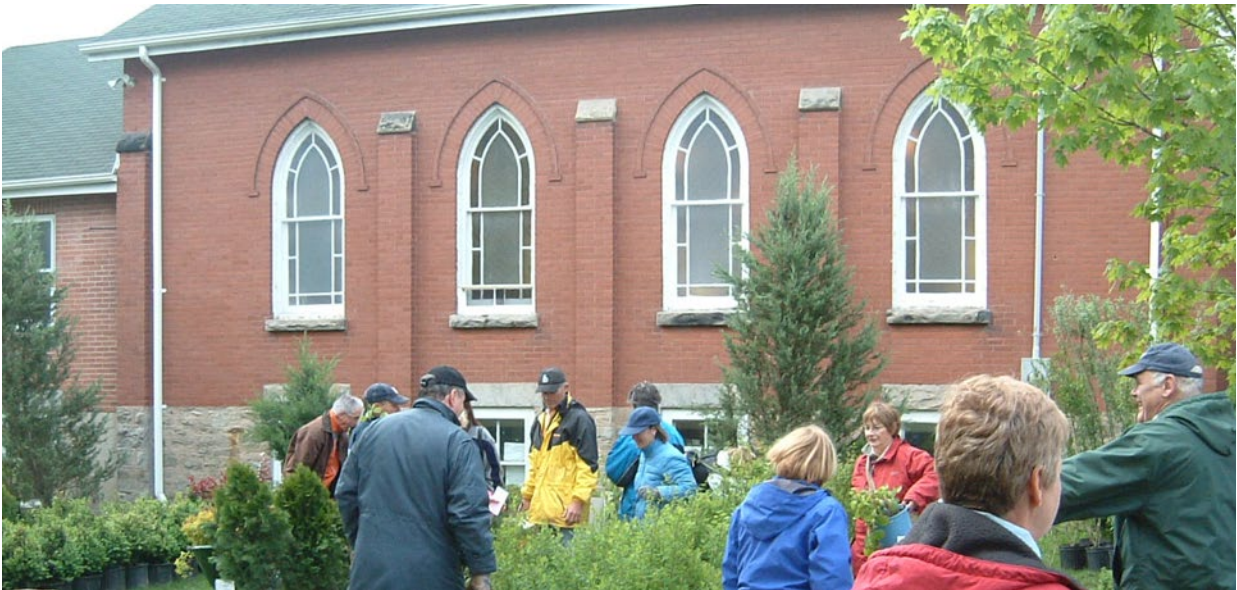
Figure 23: North side of the Church during the 2006 Town Hall Shrub Sale (J.M. Rowe June 2023)

The low-pitch roof is asphalt shingled with narrow fascia boards. They have been covered in white siding with matching gutters and downspouts. A single rectangular brick chimney sits at the rear of the original building.

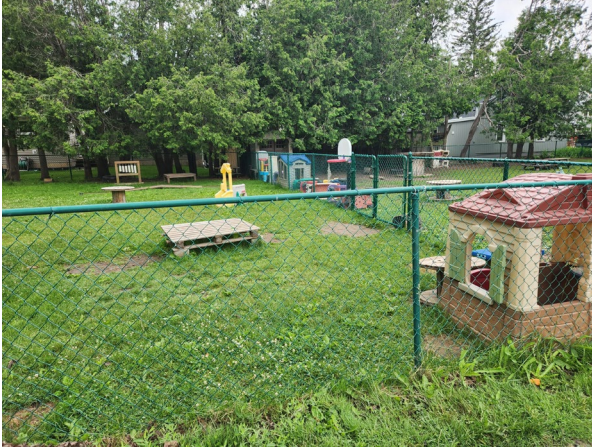
Figure 24: Looking south within the property towards the playground (Town of Halton Hills 2023)

A stone driveway encircles the building expanding into a rear parking lot. To the south of the building and driveway is a large rectangular lawn. This is now enclosed as a children's playground (Figure 24 and Figure 25).

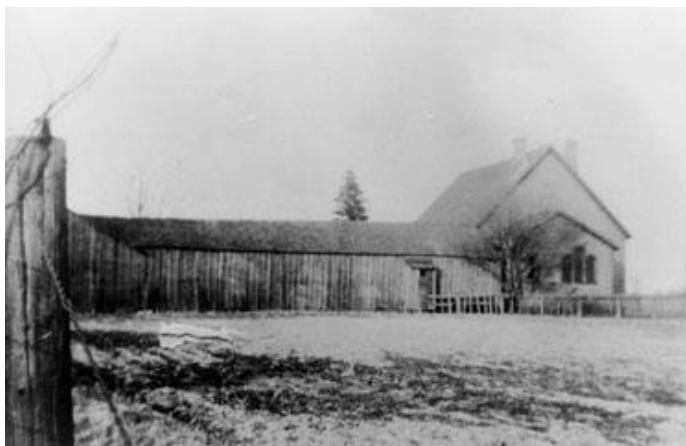
Figure 10: Rear of St. John's Anglican Church and driving sheds, which were removed in 1958, c.1948. As evidenced in the photograph, the church building has been stuccoed (EHS 475f).

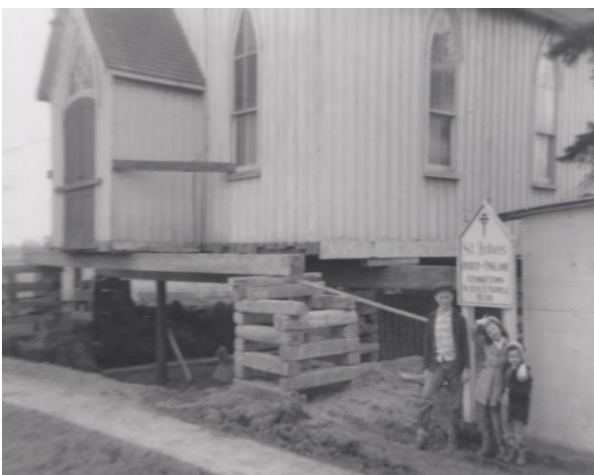
Figure 11: St. John's Anglican c.1958 during the basement construction (Courtesy of The Georgetown Vault)

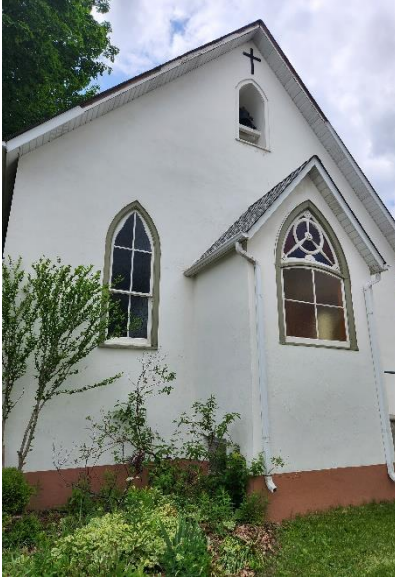
Figure 26: Front elevation of St. John's Anglican Church (Town of Halton Hills 2023)

The existing one-storey structure is a wood frame building clad with stucco, with a front gable roof. Each side elevation features three symmetrically placed Gothic-arched windows. On the front elevation along Trafalgar Road, a window opening is located on either side of the entrance vestibule which features a side double-door entrance above a flight of concrete steps. The entrance was previously centered within the vestibule along Trafalgar Road according to historic photographs. Above the vestibule and beneath the gable roof is the church bell within a recess on the front elevation. (Figure 26 through Figure 28)

The steeply-pitched gable roof of St. John's Anglican Church is characteristic of the Gothic Revival style, as are its pointed lancet windows. Aside from those features, however, the church itself is a vernacular box shape and features no other significant ornamentation on the exterior, apart from the central stained glass window within the front vestibule.

- The setback, placement, and orientation of the c.1840s frame church building at the southwest corner of 15 Side Road and Trafalgar Road
- The scale, form and massing of the one-storey stuccoed frame structure with gable roof with front vestibule;
- The materials, including stuccoed exterior;
- On the front (east) elevation:
 - The central vestibule with wooden lancet stained-glass window with wood surround;
 - Beneath the centre gable, the recessed alcove with bell; and,
- On the side (north and south) elevations, the three symmetrically placed lancet window openings with wood surrounds.

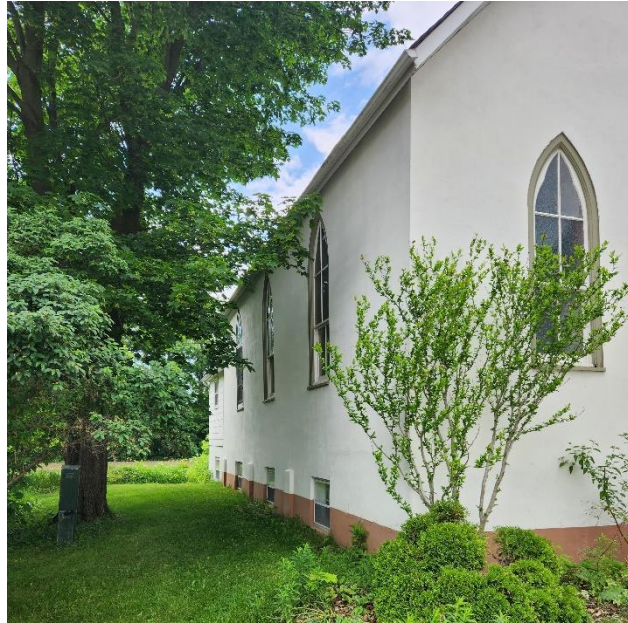
Figure 29: Side (south) elevation of St. John's Anglican Church (Town of Halton Hills 2023)

The south elevation of the church features three symmetrically placed lancet windows and flat-headed window openings at the basement level. A rear one-storey addition is visible on the west side of the original church building (Figure 29).

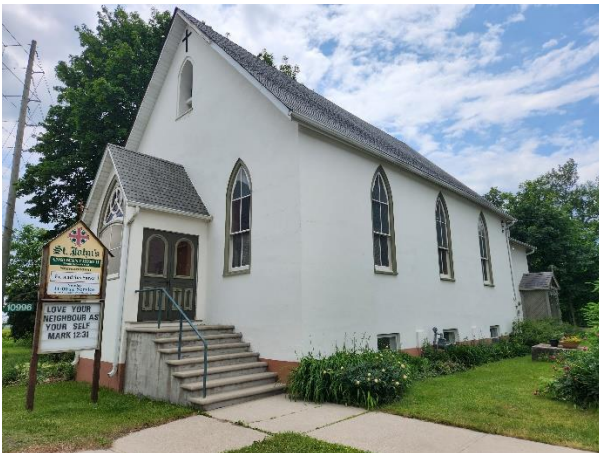
Figure 30: Northwest corner of St. John's Anglican Church (Town of Halton Hills 2023)

The side elevation along 15 Side Road features the same symmetrically placed Gothic-arched window openings with basement windows located below, and a gable-roofed entrance within the rear one-storey addition. The entrance within the rear addition is located beneath a gable roofed open porch structure (Figure 30 and Figure 31)

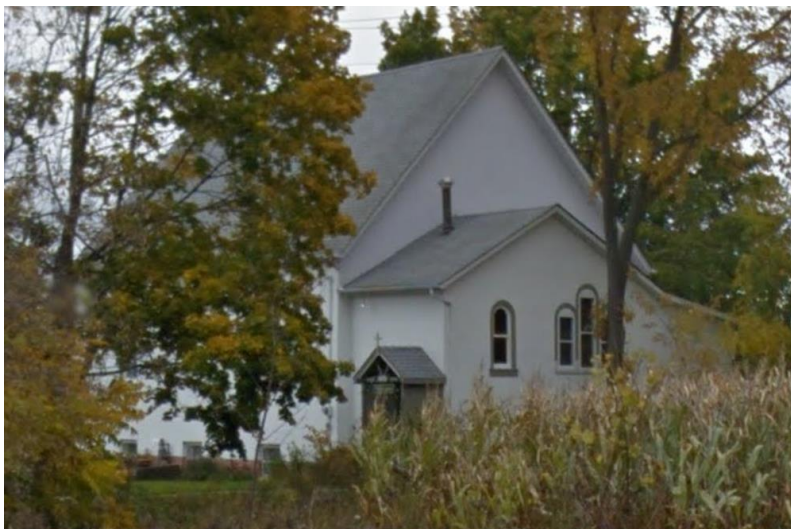
Figure 32: Rear (west) elevation of St. John's Anglican Church (Google Streetview 2021)

The rear elevation of the main church building is a blank wall with no openings, while the one-storey addition features a single round-arched window and a tripartite round window opening. A small metal chimney is located above the roof of the addition (Figure 32).
